# Case Studies in Construction Materials

## Post-restoration seismic performance assessment of a historic hypostyle mosque in Anatolia (13th century AD)

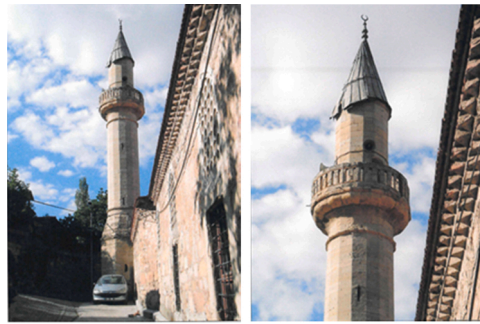
**Fig. 3.** Degradation, Decay and cracks occurred on the minaret.

Minaret	The minaret was dismantled up to the balcony and was rebuilt together with the slabs and balustrades. The cone part is covered with lead. The deteriorated stones in the entire minaret were renewed.
Main exterior walls	Cement joints on the body walls were cleaned, deteriorated and rotten stones were renewed and Khorasan-style joints were made. Window chimneys were renewed with the same-sized stones.
Slabs of women's gallery	Sagging and deflections in some parts of the slabs of the <i>women's gallery</i> were removed; its carrier system, wooden cover and underfloor ceiling covering were renewed.
Eaves	All of the eaves on the south facade were removed, the deteriorations in the eave level were corrected, and these parts were rebuilt.
Slabs	During the restoration, excavations were carried out in the mosque for research purposes, imitation brick slabs and concrete slabs were removed, and wooden slabs were placed at the original slab level.

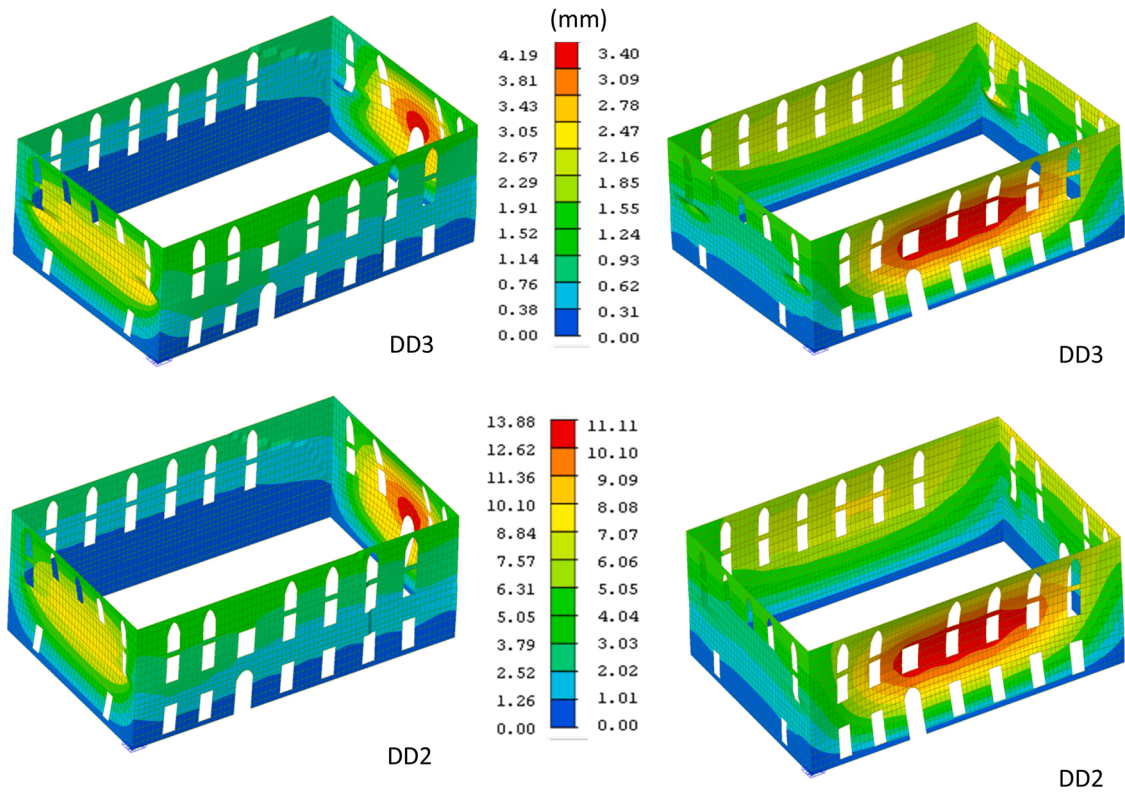
Fig. 10. Lateral displacements of the structure under earthquake effects: D+L+Exp (left), D+L+Eyp (right) (Exp and Eyp are earthquake forces in the positive x and y directions, respectively).

The displacements observed in the main building under seismic loadings in the x and y directions for two earthquake classes are given in Fig. 10. These results indicated that the building satisfies “Limited Damage” and “Controlled Damage” performance target for DD3 and DD2 class earthquakes, respectively (Table 8).

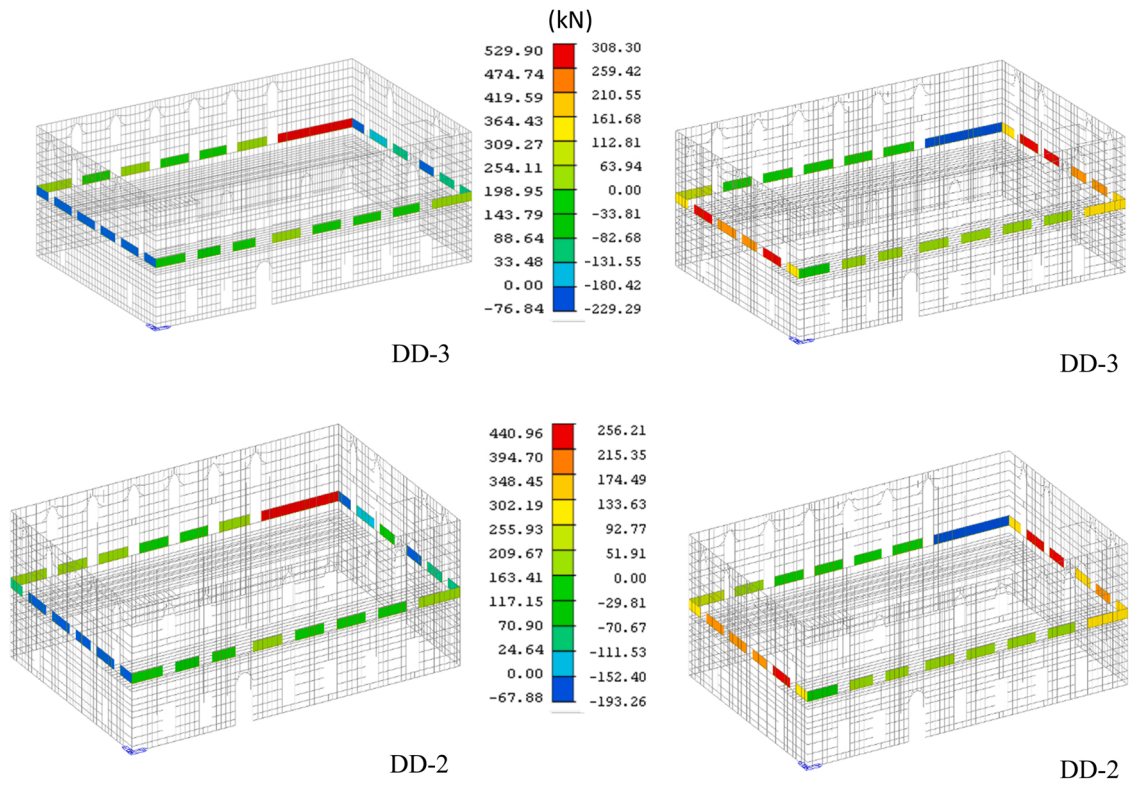
Fig. 11. Shear forces under seismic effects: D+L+Exp (left), D+L+Eyp (right) (Exp and Eyp are earthquake forces in the positive x and y directions, respectively).

Considering the vertical and earthquake loads together, the current condition of this mosque was found to satisfy the “limited damage” and “controlled damage” performance criteria for shear forces under DD3 and DD2 earthquake levels, respectively. Shear forces on the critical sections of the masonry walls generated by the earthquake forces in the positive x and y directions are shown in Fig. 11. The shear force evaluation for masonry walls in accordance with the SRMGHS 2017 [68] guide is given in Table 9.

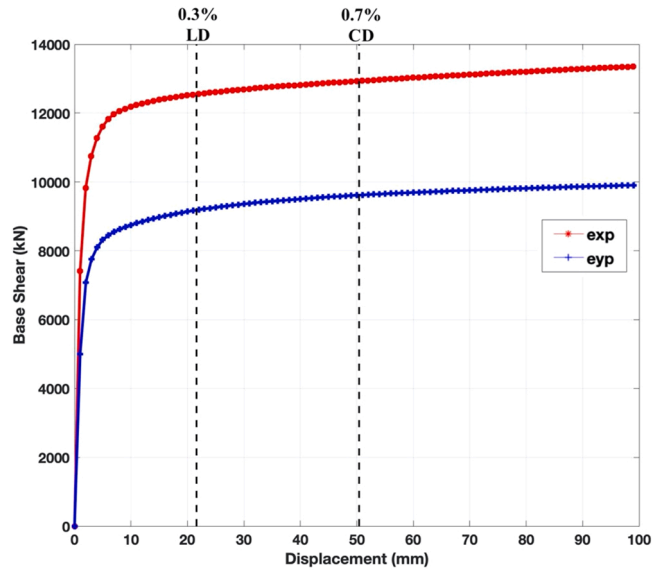
Fig. 13. Base shear vs. displacement.

The displacement curve for base shear forces in the positive x and y directions is given in Fig. 13. Lateral load capacities were found to be 13136 and 9771 kN for earthquake forces in the positive x and y directions, respectively. Vertical dashed lines in the graph indicate the displacement limits for Limited Damage and Controlled Damage performance criteria. The displacements that occurred with the pushover analysis are shown in Fig. 14.

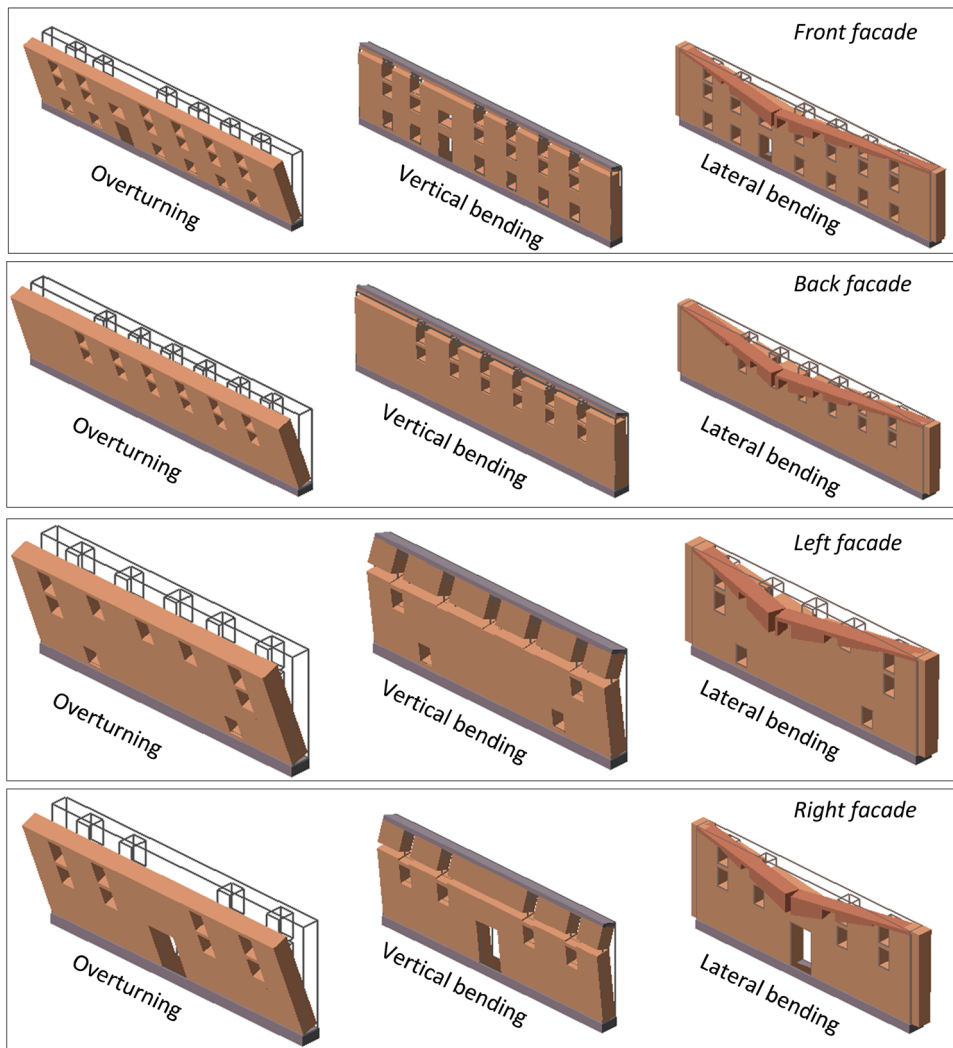
Fig. 16. Mechanisms observed for all facades.

As seen in Table 13, the evaluation of the walls indicated that the walls, in general, did not have sufficient strength against lateral bending, vertical bending, and overturning mechanisms. Although the kinematic analysis results revealed that overturning and bending mechanisms occurred on the main building, we concluded that the mechanisms observed will not pose a safety risk in a possible earthquake since the exterior walls are bonded with cramp iron.

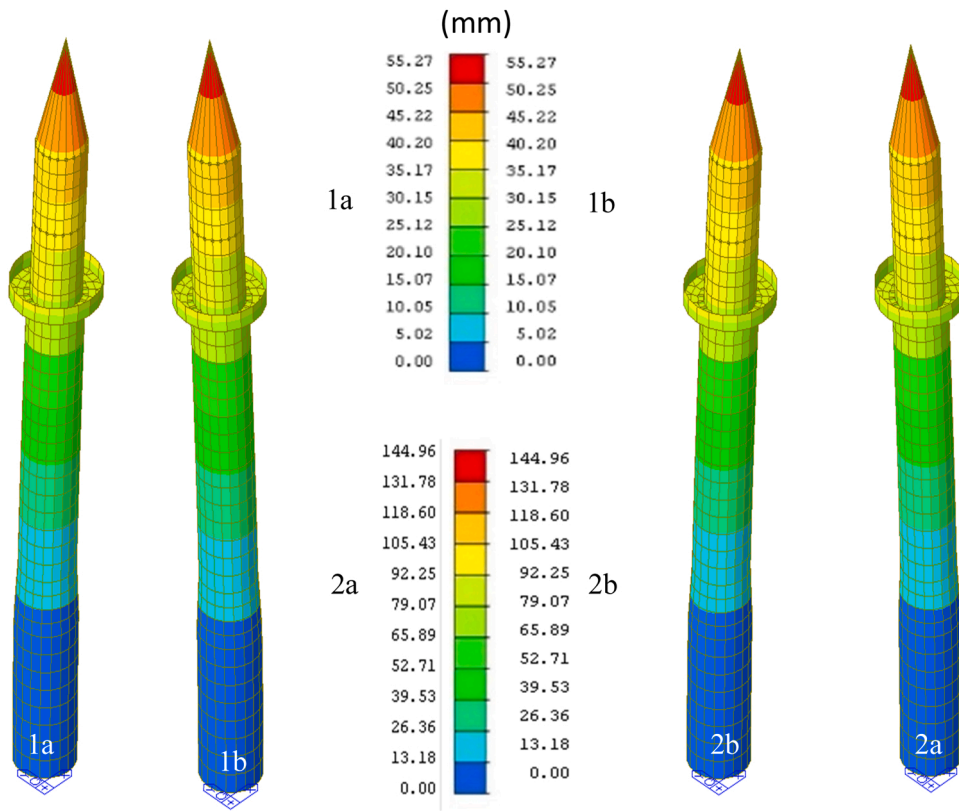
The displacements observed in the minaret under seismic loadings in the x and y directions for two earthquake classes are given in Fig. 18. These results showed that the minaret meets “Limited Damage” and “Controlled Damage” performance target for DD3 and DD2 ground motions, respectively (Table 14).

Fig. 18. Displacements observed in the minaret (1a:DD3 Exp, 1b:DD3 Eyp, 2a:DD2 Exp, 2b:DD2 Eyp).

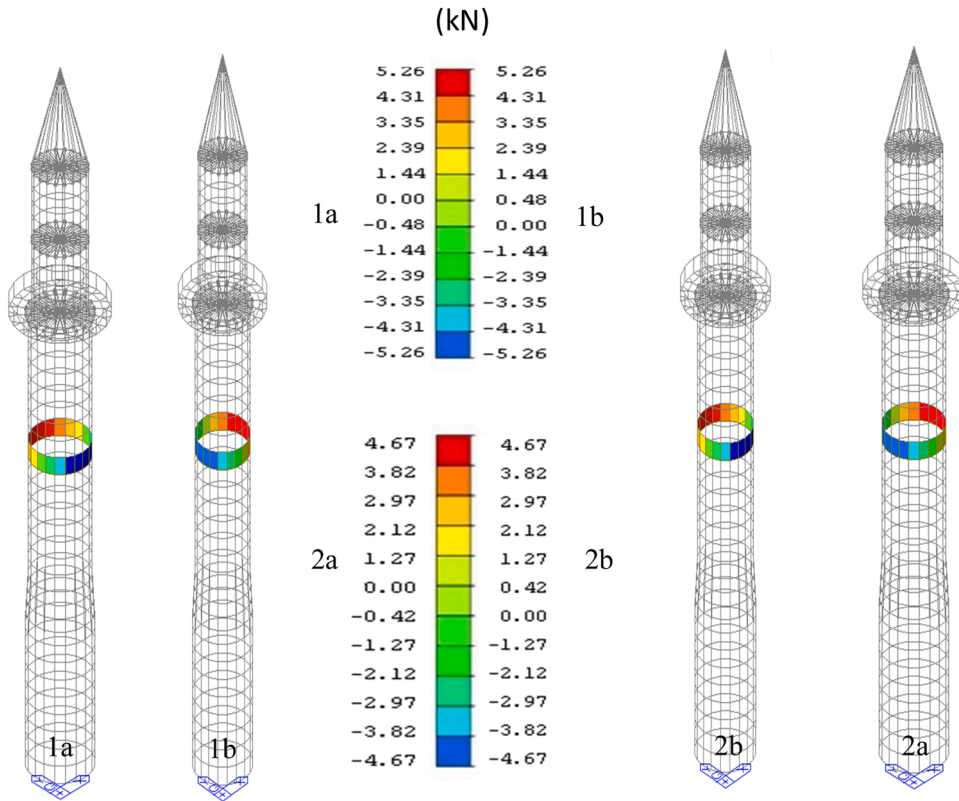
Damage” and “Controlled Damage” performance criteria for shear forces under DD3 and DD2 earthquake levels, respectively. Shear forces on the critical sections of the masonry walls caused by the earthquake forces are given in Fig. 19. Shear force checks for masonry walls in accordance with the SRMGHS 2017 [68] guide are presented in Table 15.

Fig. 19. Shear forces on the minaret (1a:DD3 Exp, 1b:DD3 Eyp, 2a:DD2 Exp, 2b:DD2 Eyp).

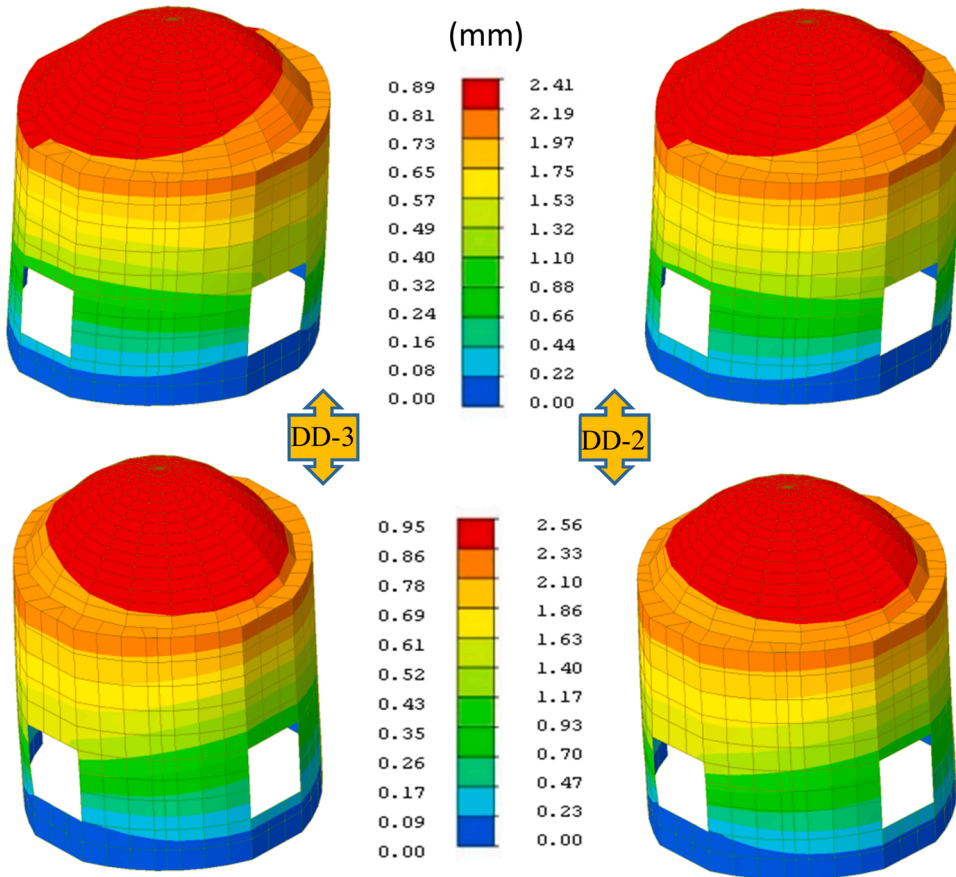
The displacements observed in the tomb under earthquake loadings in the x and y directions for two earthquake classes are given in Fig. 25. The displacement results revealed that the tomb satisfies the “Limited Damage” and “Controlled Damage” performance criteria for DD3 and DD2 earthquakes, respectively (Table 17).

Fig. 25. Lateral displacements observed in the tomb structure.

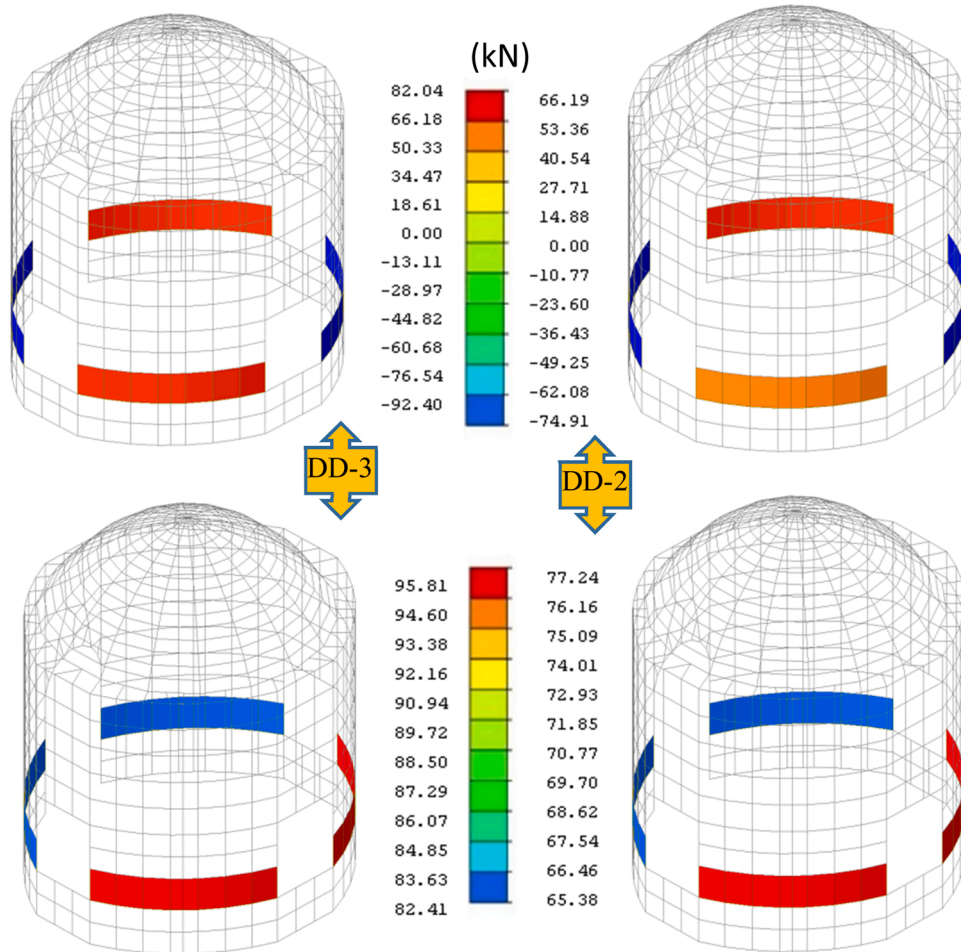
Considering the vertical and earthquake loads together, we determined that the current condition of the tomb meets the “limited damage” and “controlled damage” performance target for shear forces under DD3 and DD2 earthquake levels, respectively. Shear forces on the critical sections of the masonry walls caused by the earthquake forces are given in Fig. 26. Shear force checks for masonry walls in accordance with the SRMGHS 2017 [68] guide are presented in Table 18.

**Fig. 26.** Shear forces on the tomb under seismic effects.
