**A NEW SUGGESTION
FOR THE ARCHITECTURAL TYPOLOGY OF BODRUM:
“FOUR ROOM HOUSES”**

**A THESIS SUBMITTED TO
THE GRADUATE SCHOOL OF NATURAL AND APPLIED SCIENCES
OF
ÇANKAYA UNIVERSITY**

**BY
BURÇİN BATU**

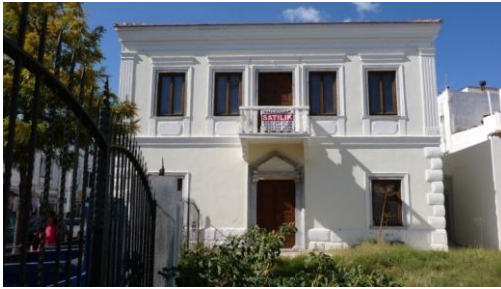
Figure 29: Front view of
29-Atatürk Street

The house has been repaired with fidelity to the original aspect, approximately 10 years ago. With this feature, it may be considered as a good example for the proper exterior repair.

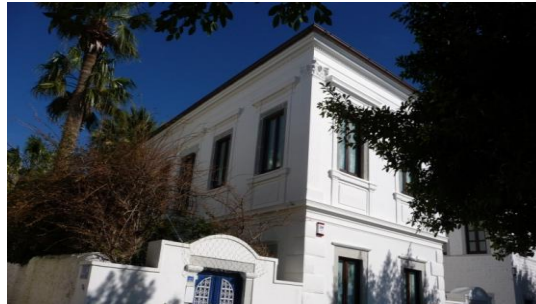
Figure 56: Front-Left view of 141-Cumhuriyet Street

Among the houses with the best condition. It is also an exception with its main door, facing the west direction, while almost all of the four room houses are facing the south direction. It draws attention with the beautiful and unique capital details. (See Appendix A4 for more information.)

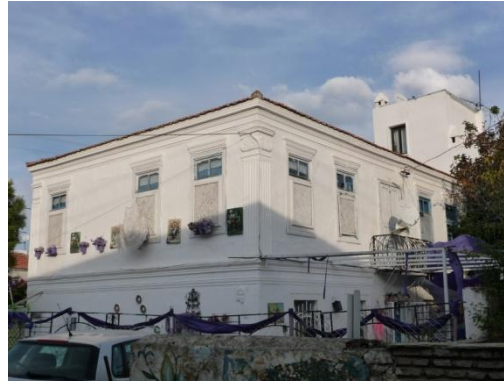
Figure 61: Front-Right view of 60-Türkkuyusu Street

Although the house has more than four rooms, it is still a good sample for the style with its every feature that repeats in all the other four room houses in Bodrum.¹ (See Appendix A19 for more information.)

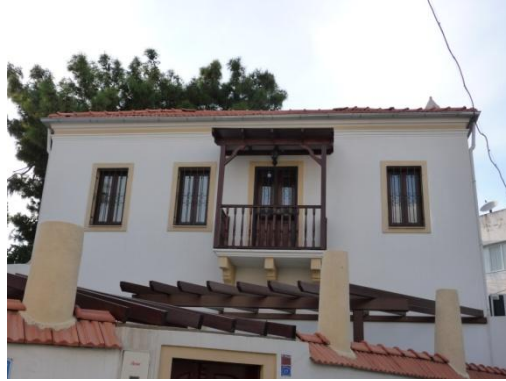
Figure 66: Front view of 17-Gerence Street

A simpler, and a smaller sample, which is presumed to be built after 1925 by the Turkish craftsmen.

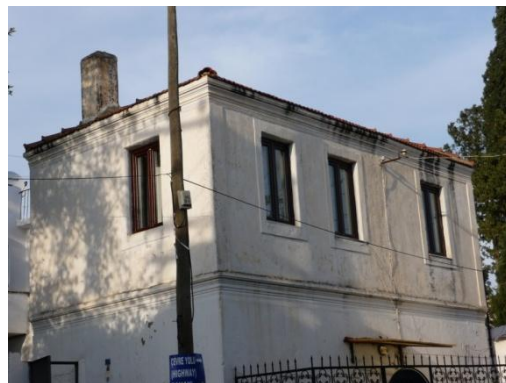
Figure 67: Front-Left view of 3-Külcü Street

A very similar sample with the 17-Gerence Street, in terms of general views and sizes. (See Appendix A17 for more information.)

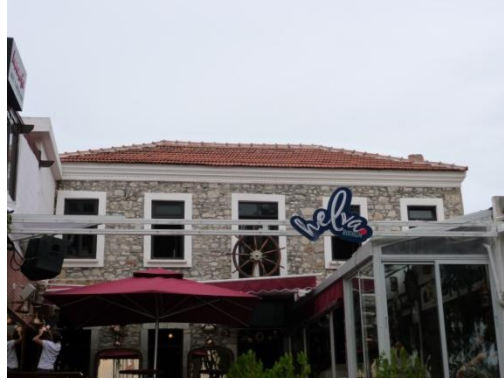
Figure 68: Front view of 44-Neyzen Tevfik street

An example, without plaster covers in the façade. Presumed to be built by the Turkish craftsmen.

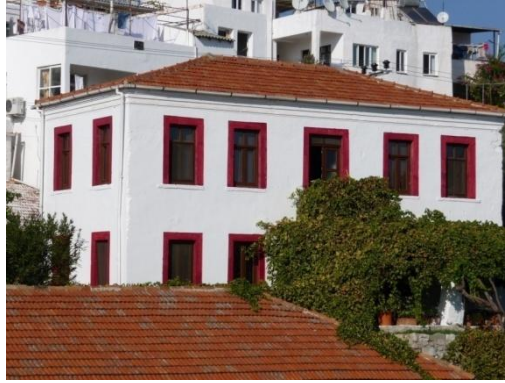
Figure 70: Front-Right view of 93-Turgutreis Street

One of the largest samples. Presumed to be built after 1925 by the Turkish craftsmen.
