# Case Studies in Construction Materials

## Post-restoration seismic performance assessment of a historic hypostyle mosque in Anatolia (13th century AD)

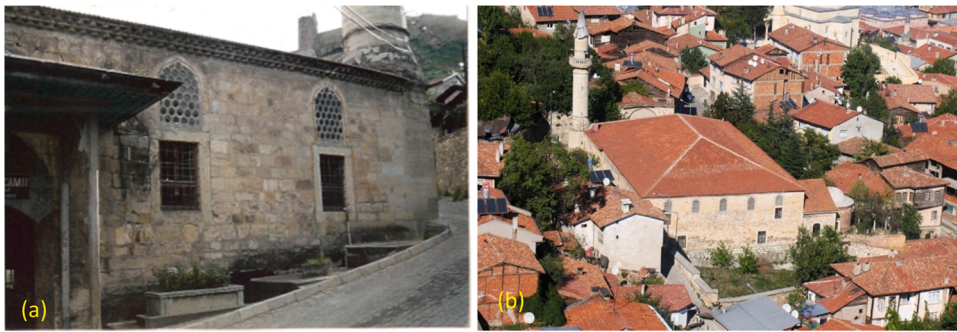
Fig. 1. The views of the mosque before the restoration. (a) Entrance, (b) Perspective.

The mosque was built in 1273 and comprises a main building and a minaret. The mosque sits on a sloped terrain in the southwest of Kastamonu, Turkey (Fig. 1). In similar mosques such as Asian and Arabian hypostyle buildings [57–60]), the span between the pillars was mostly located equally in both directions with a homogeneous distribution in the space, whereas, the central span in *Atabey Gazi* mosque is wider than the side spans, resembling a Byzantine basilica-like plan (Fig. 2). Although the name of the mosque is *Atabey Gazi*, it is also called *40 direkli cami* (mosque with 40 pillars). The main building has a rectangular form with dimensions of 30.5 × 19 m. On the northwest of the main building, there is a short minaret with a single balcony, built in the Seljuk style. The mosque is the oldest of the four mosques known to belong to the *Çobanoğulları* period and like the other three mosques, its pillars are wooden and have embroidery decorations [61–65]. However, due to the repairs performed in the past, these architectural characteristics were lost. In the southeast corner of the main building, there is a tomb believed to belong to Atabey Gazi and an additional building between the tomb and the main structure. Nonetheless, these structures were featureless and they were not included in the past restoration work.

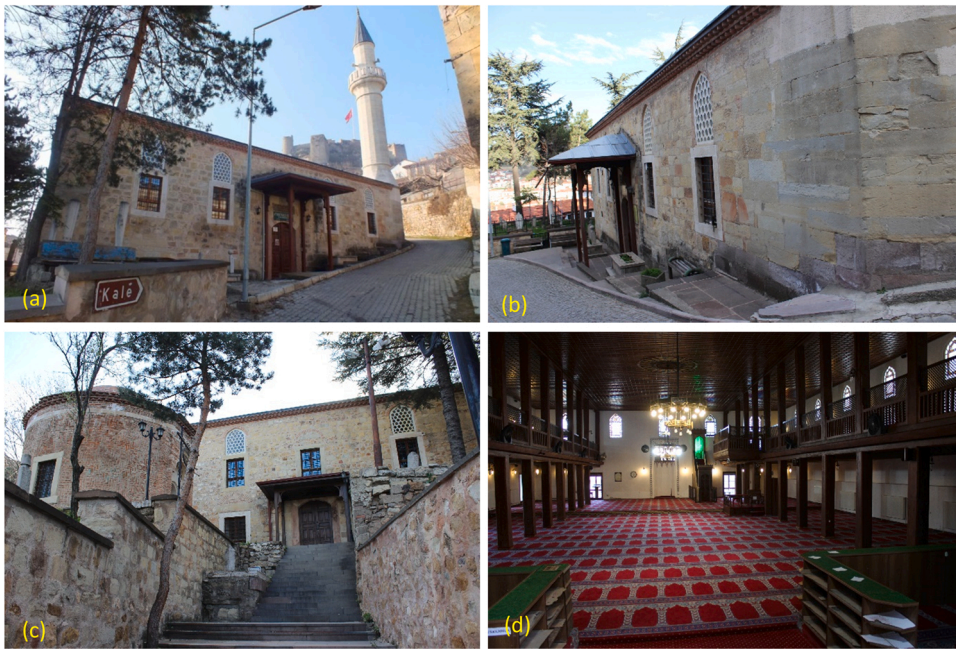
Fig. 4. Post-restoration images of the mosque. (a-c) Two entrances of the mosque (d) Interior of the mosque.

As discussed above, this 750-year-old mosque has undergone many interventions in the past. The restoration project was aimed to bring back the building to its original form and to correct the structural deteriorations and deformations in the materials inside and outside the mosque, considering the information and evidence stated in the completely reliable source document. Accordingly, a comprehensive restoration was performed in 2009. The work performed during the restoration is presented in Table 4. Post-restoration images of the mosque are shown in Fig. 4.

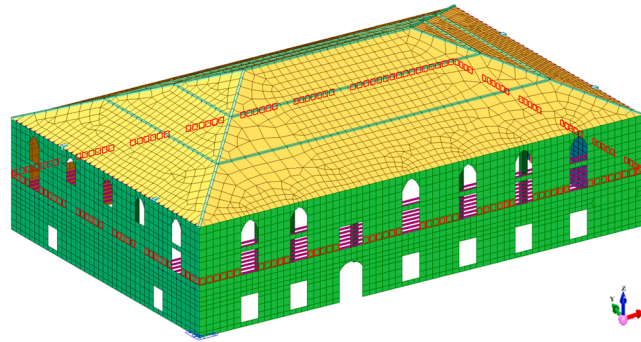
**Fig. 8.** Critical sections of the masonry walls (red-colored parts).

Critical sections selected along the window level of the main building are shown in Fig. 8. Material characteristics used in the numerical modeling are given in Table 2. Two mode shapes with the highest mass participation factors determined by modal analysis are shown in Fig. 9.

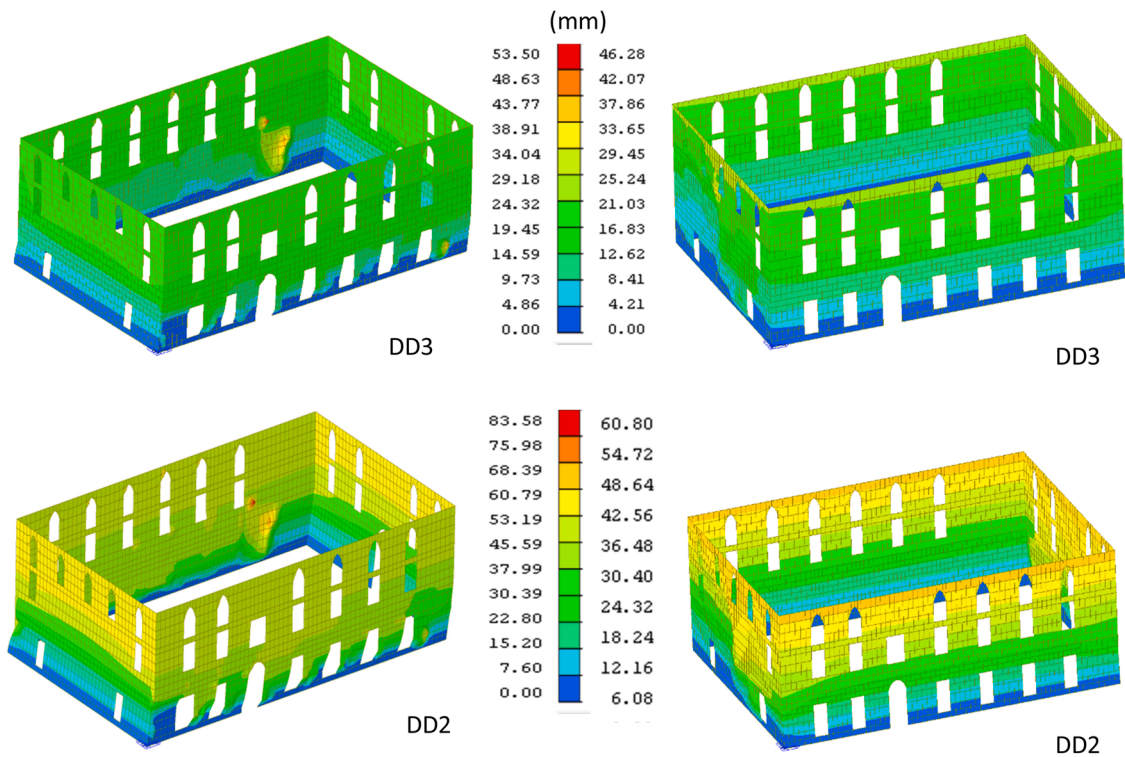
Fig. 14. Lateral displacements under seismic effects: D+L+Exp (left), D+L+Eyp (right) (Exp and Eyp are earthquake forces in the positive x and y directions, respectively).

The displacement curve for base shear forces in the positive x and y directions is given in Fig. 13. Lateral load capacities were found to be 13136 and 9771 kN for earthquake forces in the positive x and y directions, respectively. Vertical dashed lines in the graph indicate the displacement limits for Limited Damage and Controlled Damage performance criteria. The displacements that occurred with the pushover analysis are shown in Fig. 14.

According to the inter-story drifts obtained by the pushover analysis, the building was found to satisfy Limited Damage and Controlled Damage performance target for DD3 and DD2 ground motion levels, respectively.

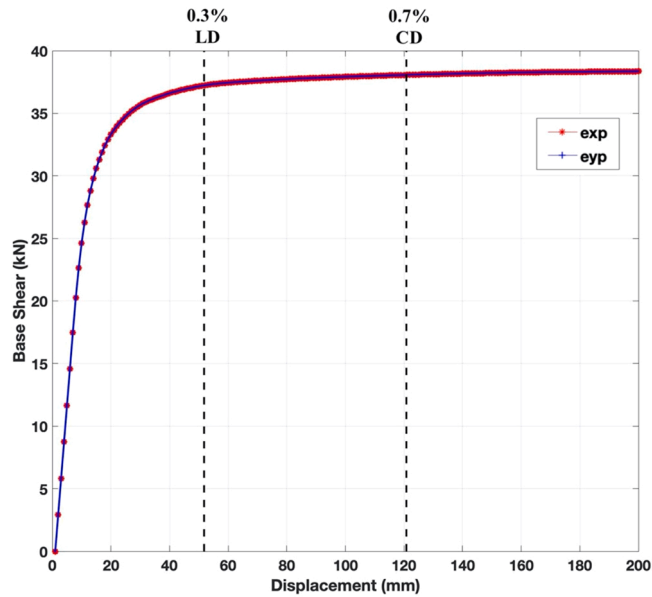
The displacement curve for base shear forces in the positive x and y directions is given in Fig. 21. The lateral load capacity of the minaret was found to be 38.3 kN for both earthquake forces in the positive x and y directions. Vertical dashed lines in the graph indicate the displacement limits for Limited Damage and Controlled Damage performance criteria. The displacements observed on the minaret by the pushover analysis are shown in Fig. 24.

Fig. 21. Base shear vs. displacement.

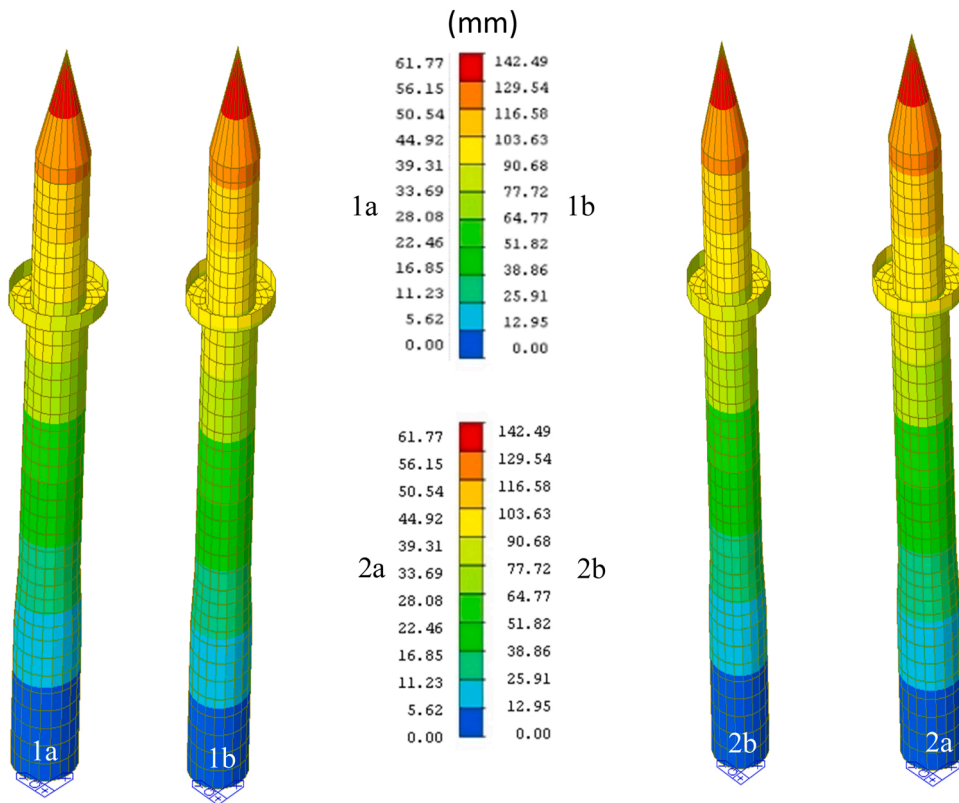
According to the inter-story drift values obtained with the pushover analysis, the minaret was found to have satisfactory strength for the “limited damage” and “controlled damage” performance criteria under DD3 and DD2 earthquake levels, respectively. Fig. 22.

Fig. 22. Displacements observed in the minaret (1a:DD3 Exp, 1b: DD2 Exp, 2a:DD3 Eyp, 2b:DD2 Eyp).

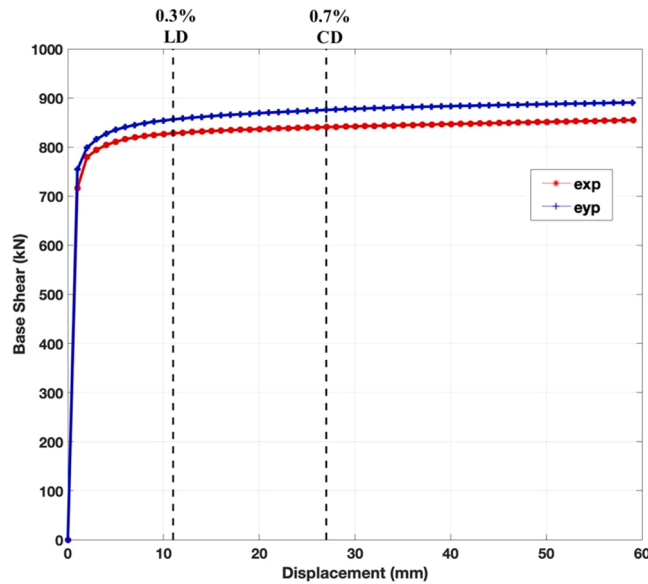
tomb were calculated as 846 kN and 883 kN for earthquake forces in the positive x and y directions, respectively. Vertical dashed lines in the graph indicate the displacement limits for Limited Damage and Controlled Damage performance levels. The displacements observed on the tomb by the pushover analysis are shown in Fig. 29.

Fig. 28. Base shear vs. displacement.

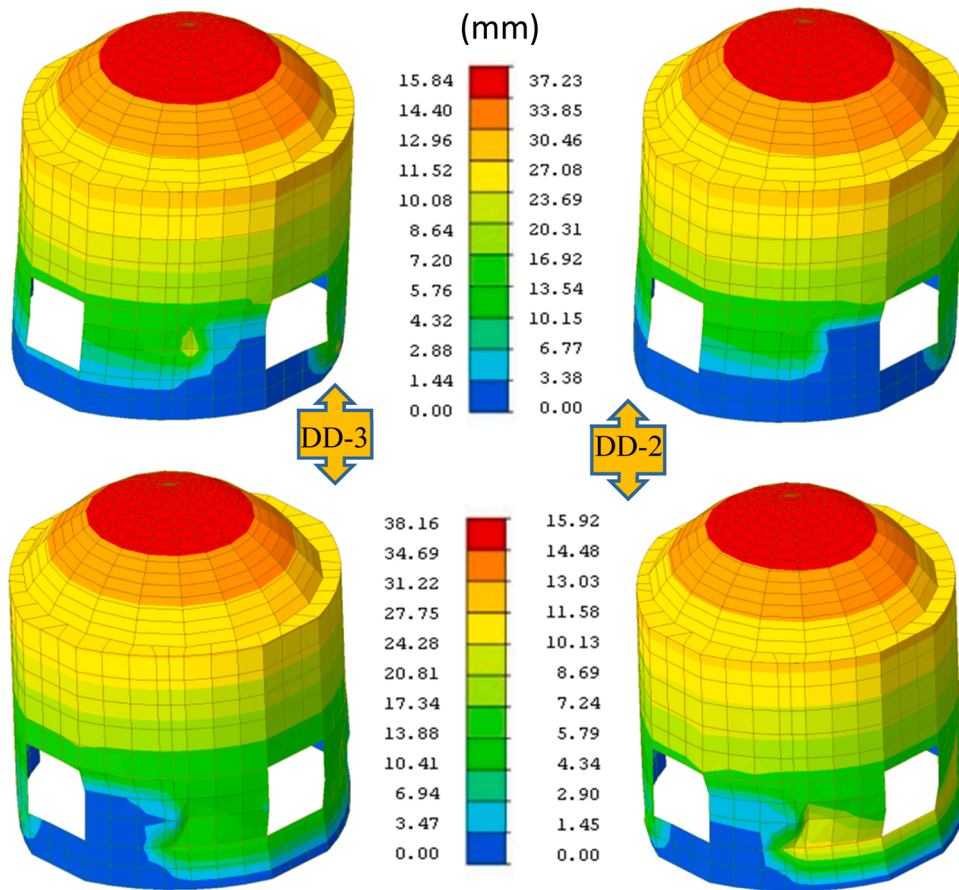
Fig. 29. Lateral displacements observed in the tomb structure.
