**RENOVATION AND RECLAMATION OF OLD BUILDINGS IN  
İSTANBUL: THE CASE OF BORUSAN MUSIC HOUSE IN BEYOĞLU**

**A THESIS SUBMITTED TO  
THE GRADUATE SCHOOL OF NATURAL AND APPLIED  
SCIENCES OF  
ÇANKAYA UNIVERSITY**

**IN PARTIAL FULFILLMENT OF THE REQUIREMENTS FOR THE  
DEGREE OF  
MASTER OF SCIENCE  
IN  
THE DEPARTMENT OF  
INTERIOR ARCHITECTURE**

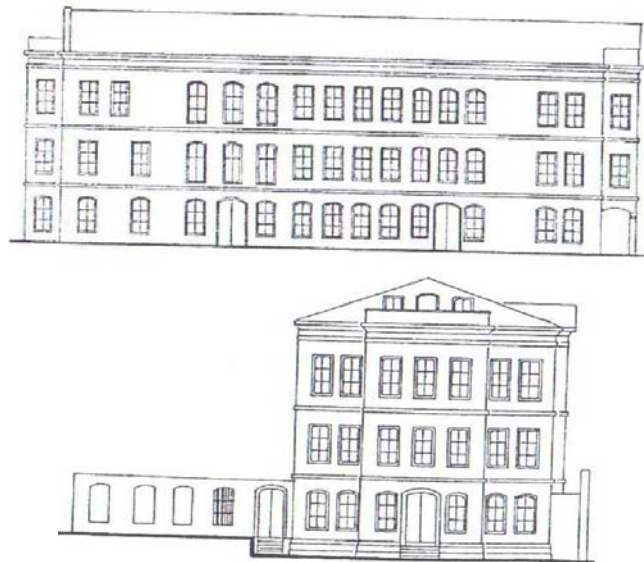
**Figure 3.5** Esma Sultan Mansion's views from side and front facade before fire

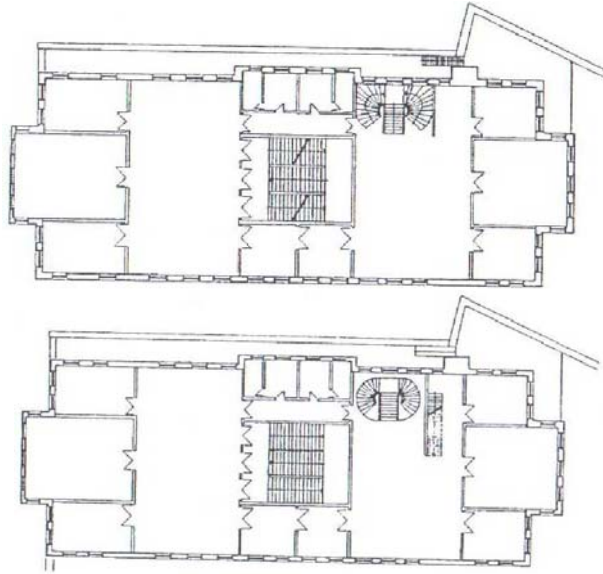
**Figure 3.6** 1<sup>st</sup> and 2<sup>nd</sup> floor plans of ESM before fire

According to the information obtained from plans before fire, the structure is consistent of six horizontal axis, three vertical floors and a terrace floor. The structure's wall thickness is seemed to be 80 cm. There are two entrances from side facade and one entrance from front facade to the building (see Figure 3.5). Passages between floors are made with large stairs at the middle of place. In addition to these stairs, there are circular shaped stairs. In drawings, a narrow staircase going up to the terrace floor is seemed (Figure 3.6). In first and second floor drawings, there are totally 12 rooms as three on the front facade, three on the back facade (Figure 3.6). On the same line with staircase, there are rooms which are probably solved by wet places. It is thought that the rest of these places were used as yards. There are big yards in second and third floors too and it is thought that they were used as today's halls. Traces of the walls separating these rooms can still be seen in the inner parts of the structure. The most significant structure element which has been lost is the roof.

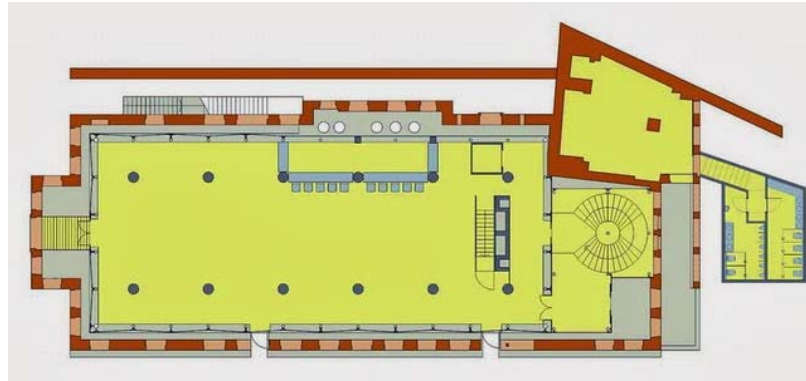
**Figure 3.8** Ground floor plan of the new structure

Current state of ESM consists of 3 floors as ground floor, basement and first floor (see Figure 3.10). In the basement, there are kitchen, restrooms and cellar. The ground floor forms preliminary acceptance part of the activity made on the first floor (see Figure 3.8). The first floor is sometimes used as an exhibition area for dining activities (see Figure 3.9).

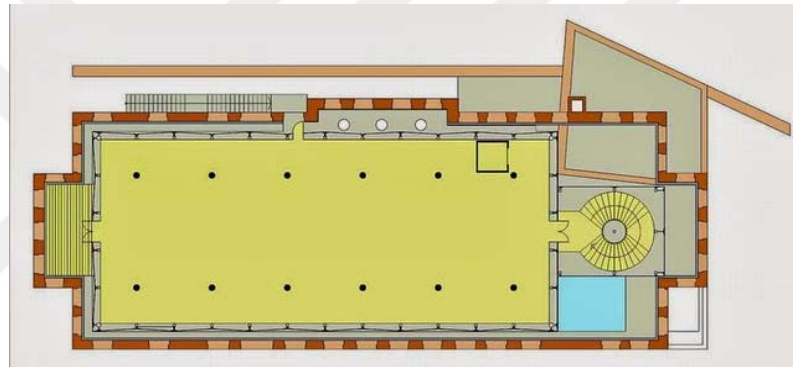
**Figure 3.9** First floor plan of the new structure

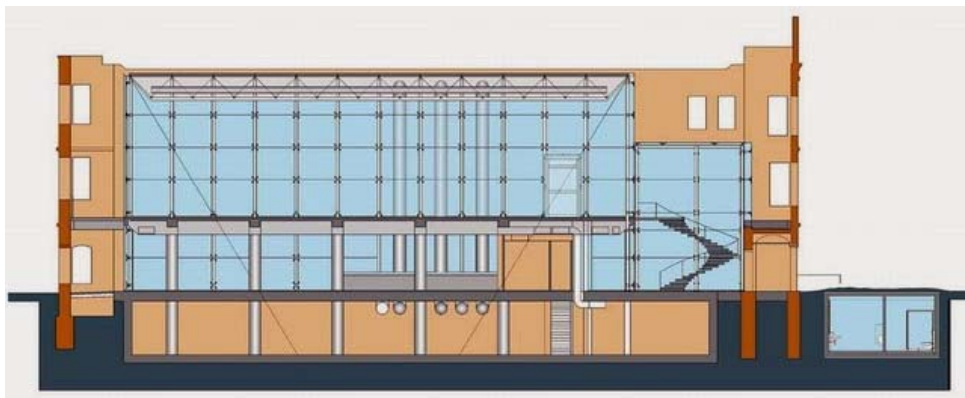
**Figure 3.10** Cross section of the new structure

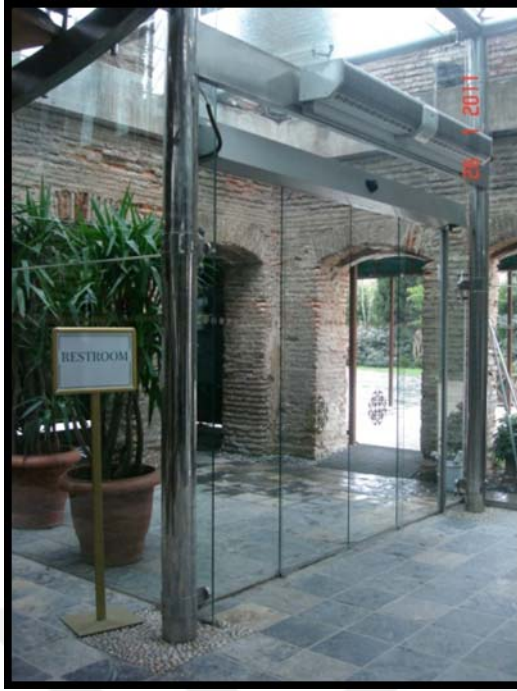
**Figure 3.11** Main entrance (photorecell sliding glass door)

Entrances and exits are made through the sliding glass on the ground floor (see Figure 3.11). Connection between two floors can be made through the steel structure large oval stairs or the glass covered elevator with steel structure (see Figure 3.12 and Figure 3.14). Double winged glass door on back side of ground floor allows entrance to the garden on Bosphorus side (see Figure 3.13). There are two single winged glass doors for entrance to the garden on side facade of the ground floor. Stairs going down from the cellar part on the ground floor are used for access restrooms (see Figure 3.15). There are four stalls in the female restroom and two stalls in male restroom (see Figure 3.16). Another stairs going down from inner part of ground floor allows access to the kitchen area (see Figure 3.17). Only element seem as fixed furniture on the ground floor is the bar between columns. The ground floor forms preliminary acceptance part of the activity made on the first floor.

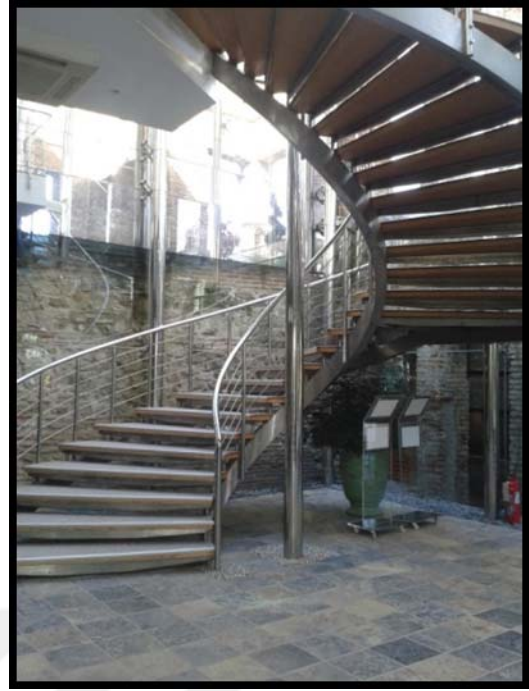
**Figure 3.12** Steel structural oval staircase

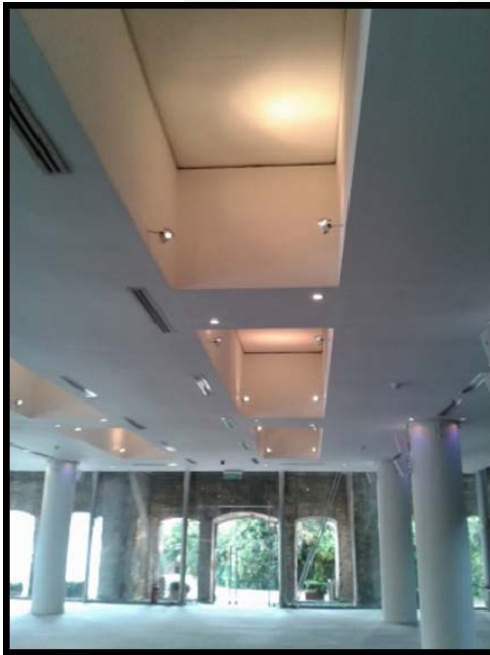
**Figure 3.13** Ground floor rear window door and suspended ceiling

If we start materials and light of new form of the structure from the ground floor, we can say that it has a fairly basic scheme. Ceiling is gypsum suspended ceiling. Artificial lighting was resolved in this suspended ceiling (see Figure 3.13). The floor is carpeted; however it is appropriate for laying different materials for different events. The walls are composed of joining of the glasses forming inner cover. Joint of glasses with each other are provided with the stainless glass holder spiders. Columns are painted with white plaster and they were left fairly basic.

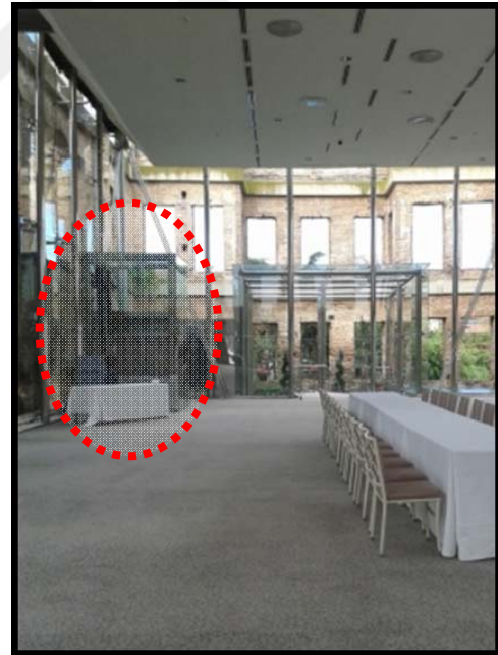
**Figure 3.14** First floor general material, elevator on the left part

higher watts. Ground floor was covered with decorative gravels from edges and the middle parts of it are carpeted. This carpet can be in different colors according to the event's concept. Wall material is glass which forms the shell of structure (see Figure 3.14).

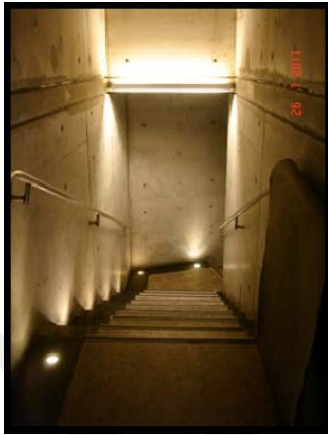
**Figure 3.15** Stairs leading to the restrooms

The walls of the stairs going down to the basement are lightened with embedded lights on the same line with steps left as gross concrete (Figure 3.15). The walls of the restrooms are also left as concrete and washbasin and door materials were selected as stainless steel (Figure 3.16). Restroom lights were made by sequencing old model light bulbs on the same line with mirrors. Again, in kitchen which is on the same line with ground floor, there are industrial type oven, counter and cabinets (Figure 3.17). Lightening is provided with white fluorescent.

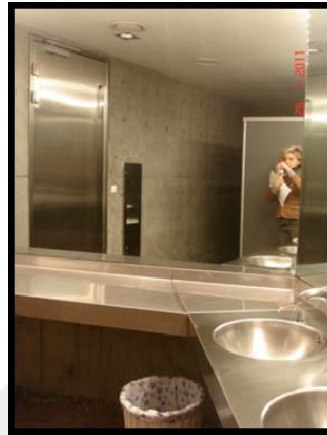
**Figure 3.16** Esma Sultan Mansion restroom

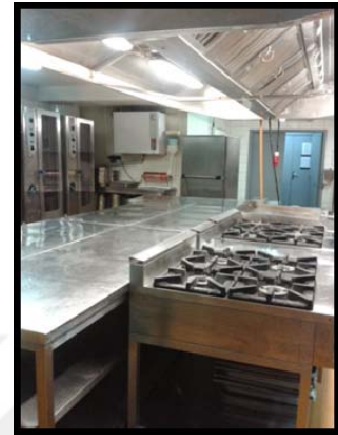
**Figure 3.17** Esma Sultan Mansion kitchen scene

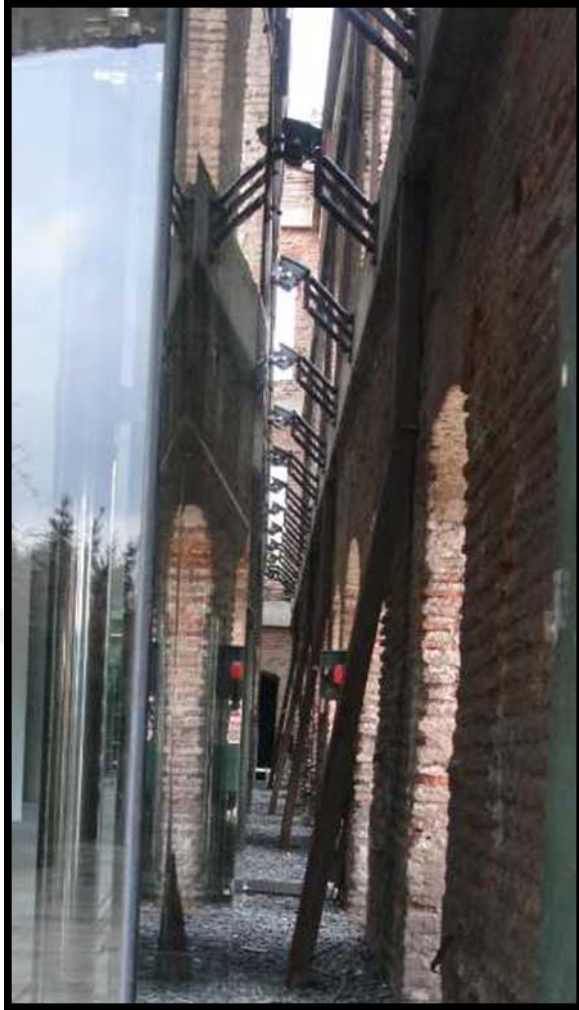
**Figure 3.18** Combination of old brick facade and new steel structure

Space between glass-steel system and stack structure was made decorative with the gravels on the ground (see Figure 3.18). Ventilation systems are also resolved in this space. Another application resolved in this part of structure is assembly of strengthening elements to the gravel ground. Profiles carrying the stacked side are put in these spaces with systematical intervals (see Figure 3.18). In addition, there is a very important system for safety of place on this part. This system is the hydraulic pistons located between interior and exterior covers (see Figure 3.18). This hydraulics absorbs the mobile-horizontal load to be created by earthquake on the structure and it protects the structure against damages such as sliding and cracking. This hydraulic system is located around the structure from ground floor to the ceiling level.

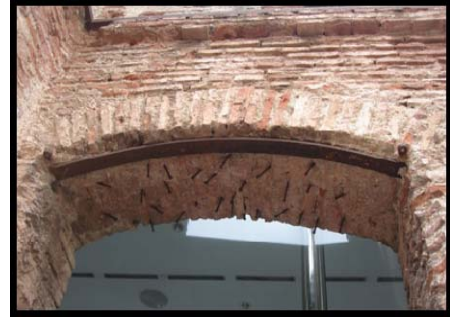
**Figure 3.19** Belt reinforcement

Stack cover is reinforced from inside and outside during renewing works. Reinforcement works are made with curved profiles and screws on belts (Figure 3.19). Screws which seem to be places randomly are normally located on points which are deemed appropriate by experts.

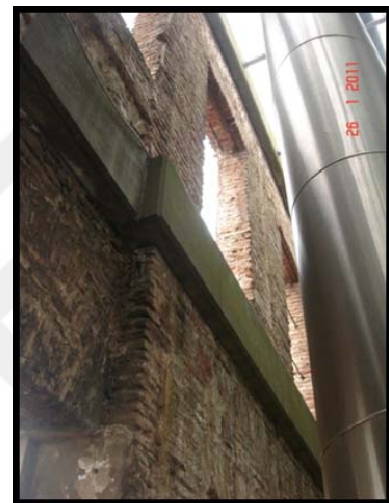
**Figure 3.20** Retrofit reinforced concrete brace or wrapping

Another important reinforcement application is the reinforced concrete belt reinforcements along the length in approximately 50 cm of height (Figure 3.20). This method is also called wrapping method. It is a commonly used method in structure reinforcement. It is possible to use vertically and horizontally (see Figure 3.21). It was used horizontally in ESM's reinforcement. Application of reinforced concrete was told as follows in Cogurcu's master thesis: Firstly, it must be purified from the mortar to be poured on the area to be subject to the process. In this way, concrete to

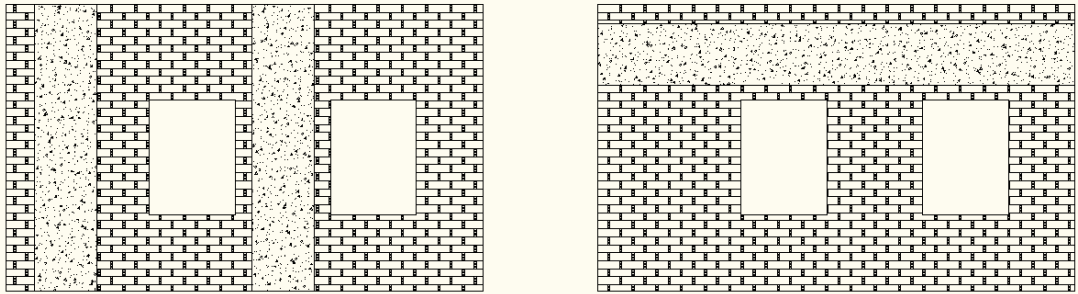
be sprayed in the further stages of process will be integrated with the walls of structure better. Then braided steel will be located on the cleaned area. High pressure cement-sand mortar will be sprayed onto this reinforcement. Finally, this process will be continued until 5 cm of concrete belt is created on the wall [26].

**Figure 3.21** Vertical and horizontal application of reinforced concrete wrapping method on brick-masonry building

This process was applied in ESM in two stages in such manner that it covers the structure tightly. Tile alignment was determined as the axis on which this process was to be applied in the former state of structure. Secondly, this process was applied on the upper line of outer cover. As the masonry facade is exposed to too much wind, wrapping protects the facade from cracking.

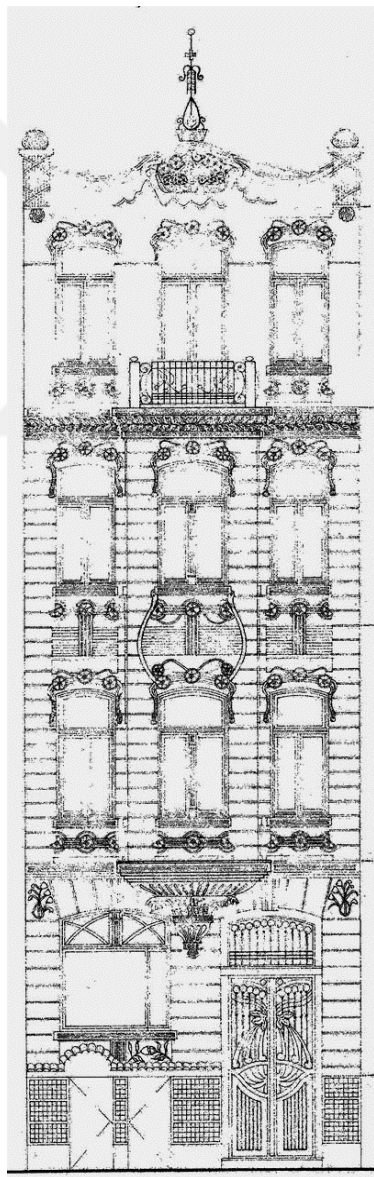
**Figure 3.22** Old exterior facade drawing of Changa Restaurant

Restoration of the building was made in 1903 in Taksim Siraselviler Caddesi No: 47, was made by adding modern elements and parts (see Figure 3.33). As can be understood from the front facade, it is consistent of three floors (Figure 3.22). As can be seen from the front facade drawing of new front facade, two more floors were made on steel construction on three floors (Figure 2.23)

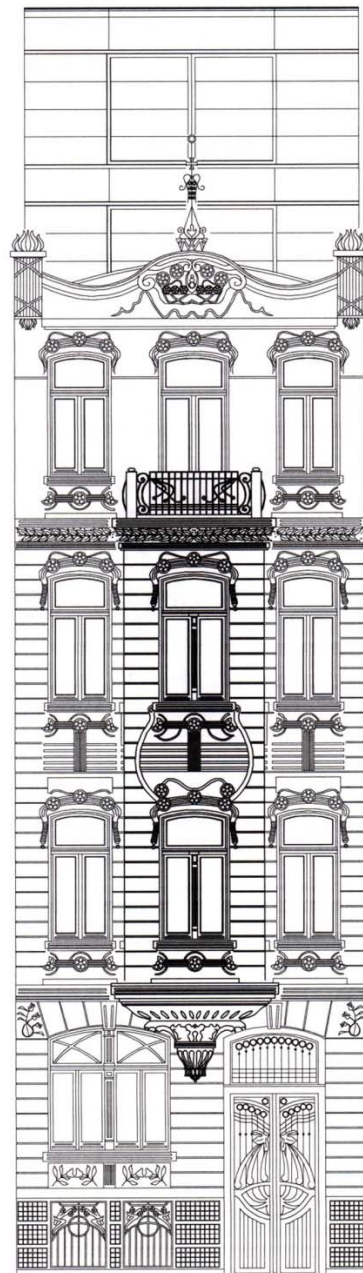
**Figure 3.23** New exterior facade drawing of Changa Restaurant

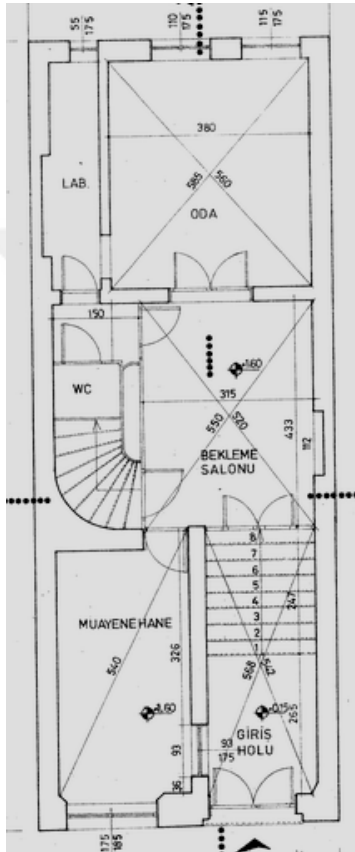
**Figure 3.24** Changa

Firstly, if we examine the structure upon older plans: it is seen that we can access to the waiting hall after climbing 8 steps from the main entrance, then examination room when directed to the front facade and then the laboratory part from room place (Figure 3.24). In addition, it is possible to access to restroom part, laboratory and stair to the upper floors from waiting hall.

Restaurant's former ground floor plan

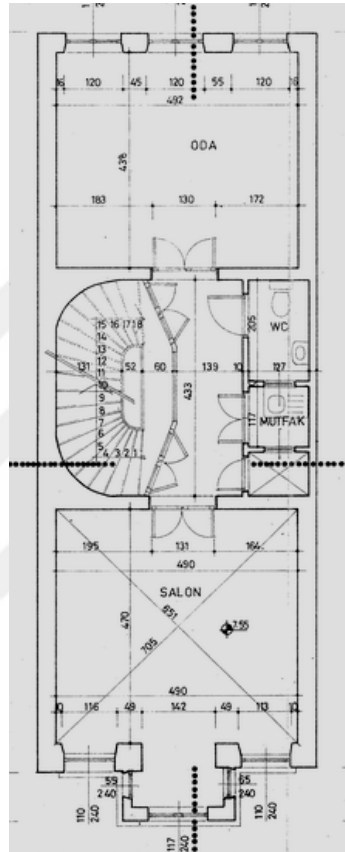
**Figure 3.25** Changa

Restaurant's old first floor plan

Passage is made through glass doors to the second floor which can only be accessed with stairs coming from ground floor and passing from the first floor (Figure 3.25). This place, which can be named as hallway, directs you to the main hall from the right to the front facade, to the room from the left to the back facade. Alignment of the middle window is seemed as bay window on the hall. The rear room has three

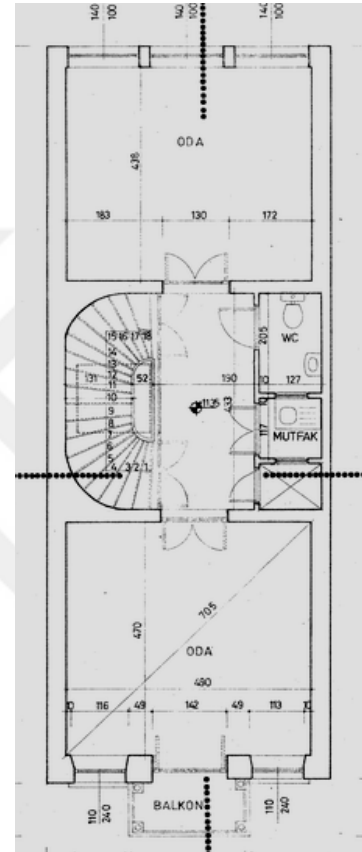
**Figure 3.26** Changa

Restaurant old second floor plan

Third floor, which is accessed from the stairs from second floor, is similar with the second floor (see Figure 3.26) with the exception that there is no showcase at the doorway section of the third floor. Also, the bay window section on the second floor becomes a balcony on this floor.

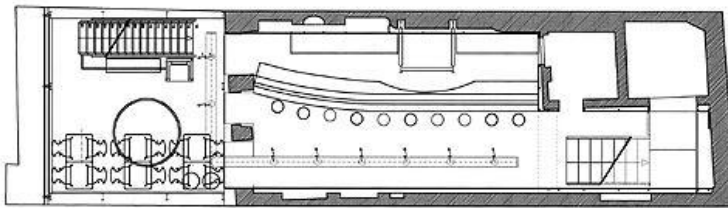
**Figure 3.27** New bar floor of Changa Restaurant

There are bars and tables on the bar floor which is accessed by stepping down 8 steps from the main entrance (see Figure 3.27). According to the information obtained from images, the ground is coated with concrete-looking gloss epoxy. The ceiling was obtained by painting the tiles on original plan of structure (see Figure 3.36). Drywall was only used for increasing design trace of bar on the same line with bar. Niches used behind the bar has determined the wall materials and they have been deemed appropriate for locating bottles and glasses to be used in the bar. Besides, large bulge on back side of the bar is used as screen. When the plans of upper floors are examined, it is thought that this place was used as the technical size of elevator. On this floor, ventilation pipes were left empty to be used as design elements.

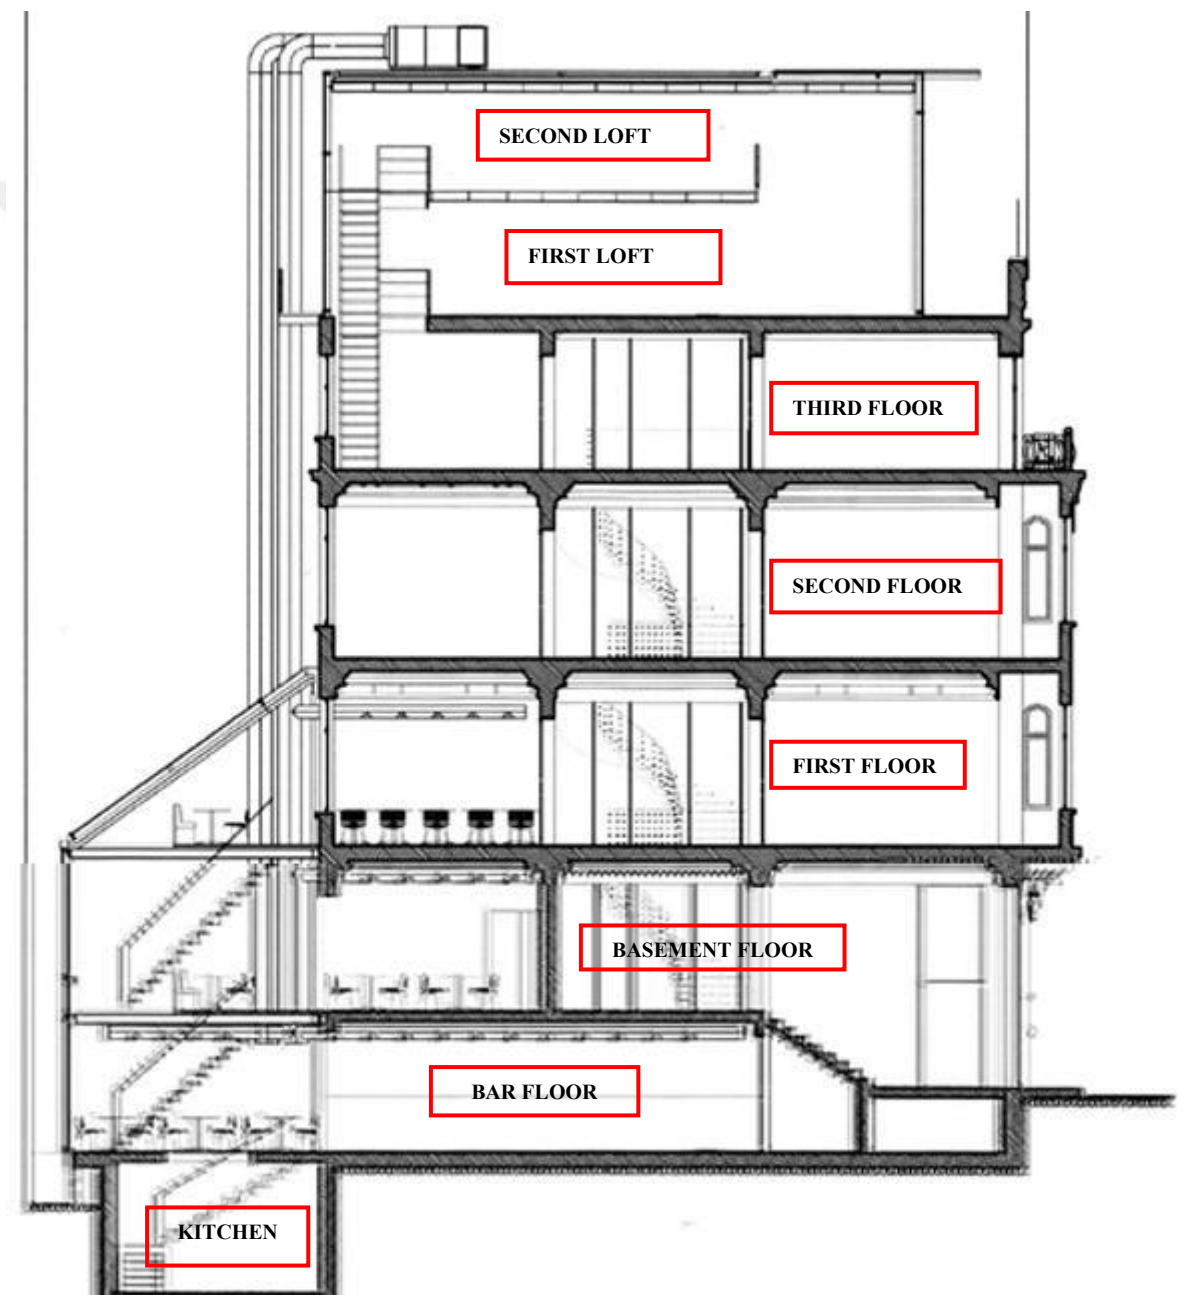
**Figure 3.32** The new cross section of Changa Restaurant

First floor has an outer facade like greenhouse. Front facade is a place with bay window (see Figure 3.32). The ground is covered with wood and the walls look like gross concrete. Upper floor can be accessed with elevator or the original stairs of building on the middle axis. Again this elevator and staircase allows access to the third floor from second floor (see Figure 3.32).

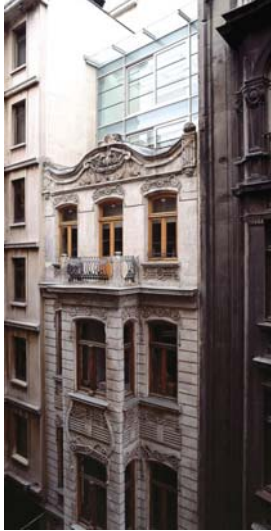
**Figure 3.33** Changa Restaurant's new front facade

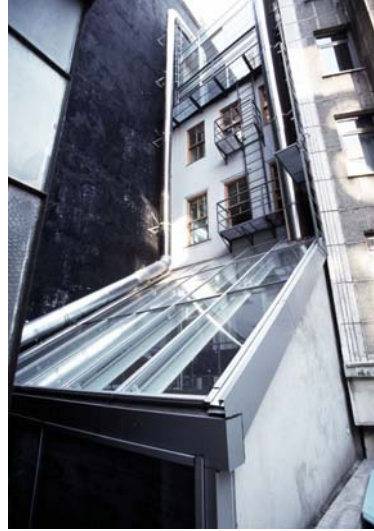
**Figure 3.34** Changa Restaurant's new rear facade

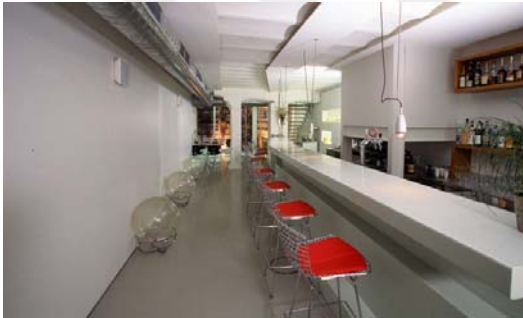
**Figure 3.36** Changa Restaurant bar scene  
voltaic tile ceiling, floor epoxy

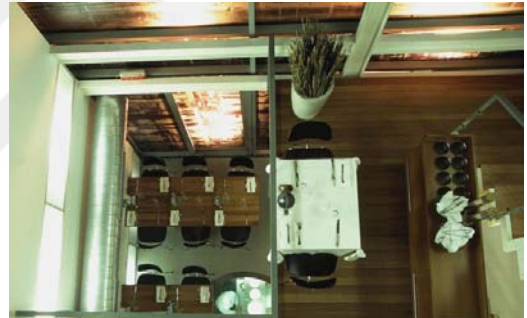
**Figure 3.37** Changa Restaurant interior gallery space

According to the information obtained from cross section, the ground floor which is accessed by climbing 8 steps from the main entrance can also be accessed with the stairs closer to the bar floor's rear facade. The ground is covered with wood. Table and chairs seating layout continues here and the same of stairs going up to this floor from bar floor allows access to the first floor (see Figure 3.37).

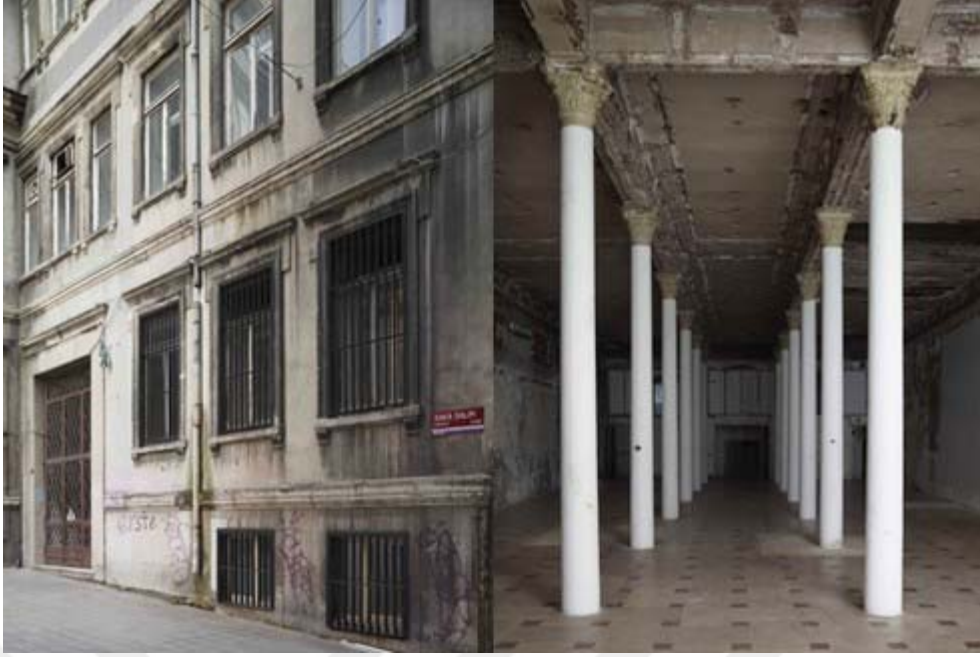
**Figure 3.38** Salt Beyoğlu's old side facade

bookseller are accessed upon the place with beamed ceiling (see Figure 3.43). These columns look like colonnade due to the fact that interior walls on the ground floor wracked in time; however the columns on ground floor were protected during restoration (see Figure 3.38). It is thought that the name 'Forum' of this place is due to the fact that Salt targeted to make this institution a discussion platform and the institution is a public place. Double row colonnade can be seen as an element giving reference to public places such as store and passage which strengthens the feel of publicity. Forum part which covers most of the ground floor is a multi purpose area as well as an exhibition, meeting and seminar area. The place is also an information area and daily program information of events in Salt Beyoğlu and Salt Galata are announced on the boards on the wall (see Figure 3.43). When we walk on the floor in the direction of double row columns, we see reservation counter at the end after seeing "Open Cinema" on the right. This place is free and public. In addition to films shown during the day, events, interviews, speeches and performances are made in this place. "Forum" part has a flexible and variable space arrangement. Figural and functional flexibility brought by fixed planning and lack of function is an important feature in terms of publicity. There were times when it was only used as exhibition and information area but it was also used as both exhibition and discussion area. In a period of a couple of months when this examination has started, covering April 2013, there were no exhibition in Forum part and people used to come and sit to spend their free times here by the columns. This furniture allowed people sit as much as they want and communicate when they want. During visits made in the place, it was observed that people from all groups of the society come to this place and some people sit and spend time here before going up to the exhibition floors. At this point, a seat element in the place has been integrated with the function of place and the sitting banks in parks which are public areas. The place has turned into a closed city park. The difference between a real parks and the place was that there were light games and organic smell of iron instead of trees and sky and there was another forest atmosphere consisting of columns reflecting green. On June, 2013, an installation covering almost whole of the entrance area was made and all seat groups were removed. In this case, this place has lost most of its publicity and it left its former livelihood and movement. Then the place became home for another exhibition as one of the main places of 13<sup>th</sup> İstanbul Biennial between September 14 – October 20, 2013. In this exhibition, installation named "Sunday or Death" of Argentinian Artist

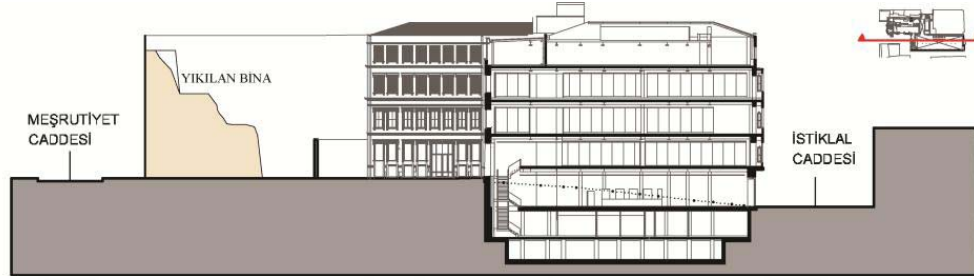
**Figure 3.40** Salt Beyoğlu new section [28]

An office floor which was not present in the first years was added to the structure and it preserved its floor persistence until today. With this addition, the structure is formed of ground floor, 3 floors, roof floor and three basements (see Figure.3.40) [28]. It is consistent of two blocks continuing by breaking backwards rather than its narrow view from the front facade (see Figure 3.41). The blocks were named as A and B. The building has three entrances. The first one is the main entrance from İstiklal Avenue, the second one is Bistro Entrance accessed by following Saka Salim Cikmazi and the third one is the unused entrance made of the second platform of forum stairs intersecting with the yard's level [28].

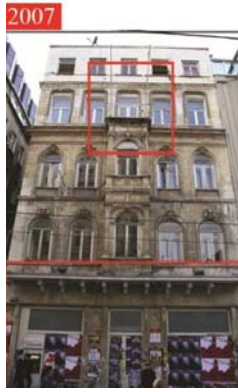
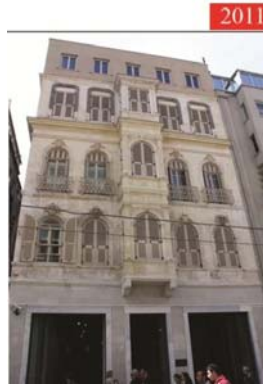
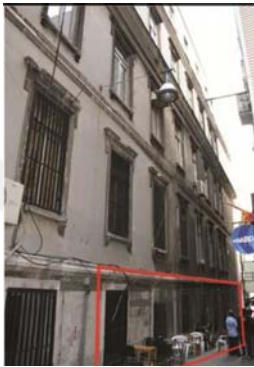
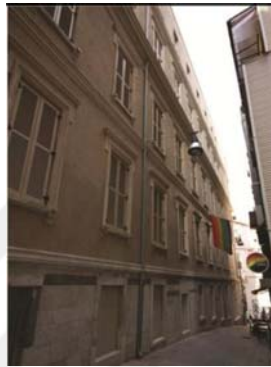
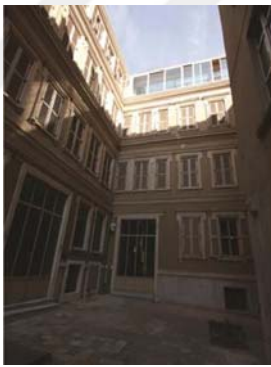
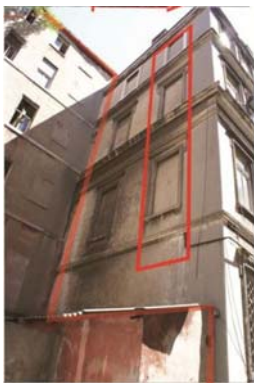
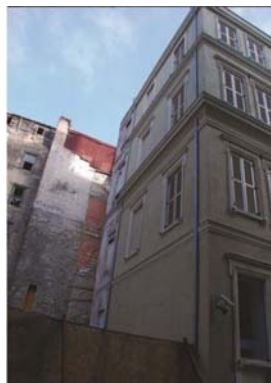
Bay window has been added to the third floor. Ground floor entrance icicle has been removed and facade has been renewed.

Windows gaps on the first basement floor have been filled.

The fourth-floor balcony has been canceled. Vitrines have been added to the garden on fourth floor.

Fire escape windows have been opened. Entire of the rear wing facade has been uncovered after demolition of adjacent buildings.

**Figure 3.42** The changes made on Salt Beyoğlu's facade [28]

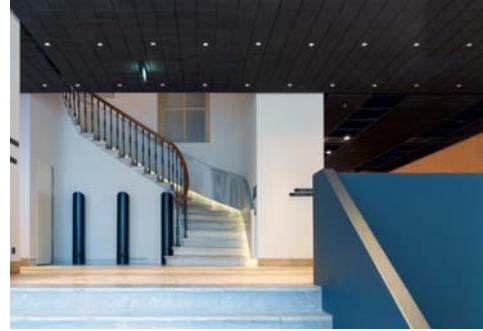
**Figure 3.44** Restoration of the old stairs

Wood tile coating ends at the beginning of stairs of floor and the original marble coating on steps create their own borders between each floor. When experiencing the steps, time - place contradictions are experienced in hidden yellow led and railings added later (see Figure 3.44). On one side, iron rod and wood handle railings belonging to its own period and on the other side, marble baseboard with latest period lightening technique. While on move, two square windows on the large wall are seemed [28].

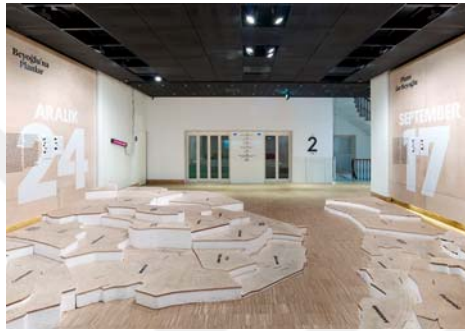
**Figure 3.45** Location of glass elevators from the exhibition area

Tümertekin, who mentioned that the fact that exhibition areas are covered with industrial tiles, expresses that they would like to create an exhibition area which has a warm atmosphere and they would like to break the perception of classical exhibition (see Figure 3.45). In addition, it is stated they preferred an element which would be wondered by the visitors in addition to calm and visible exhibition stands and ceilings with black metal perforations. In this way, some pen works have been behind the metal perforated ceiling, but the perforated ceiling gives reference to its history behind the perforations [28].

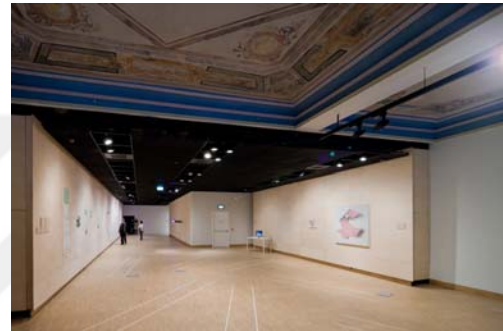
**Figure 3.46** Integration of old and new ceiling

The part on which pen work decorations can be perceived clearly on the ceiling is the part on 5 meters of depth from the windows' axes on French balconies in A Block (see Figure 3.46). Other than the pen works clearly perceived in the exhibition area,

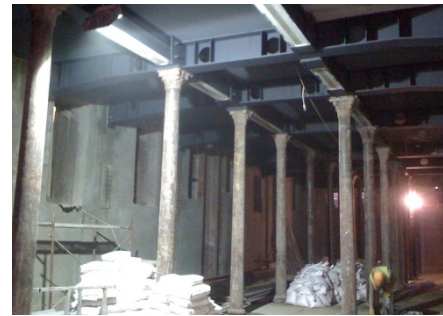
**Figure 3.48** Construction work on the Forum area

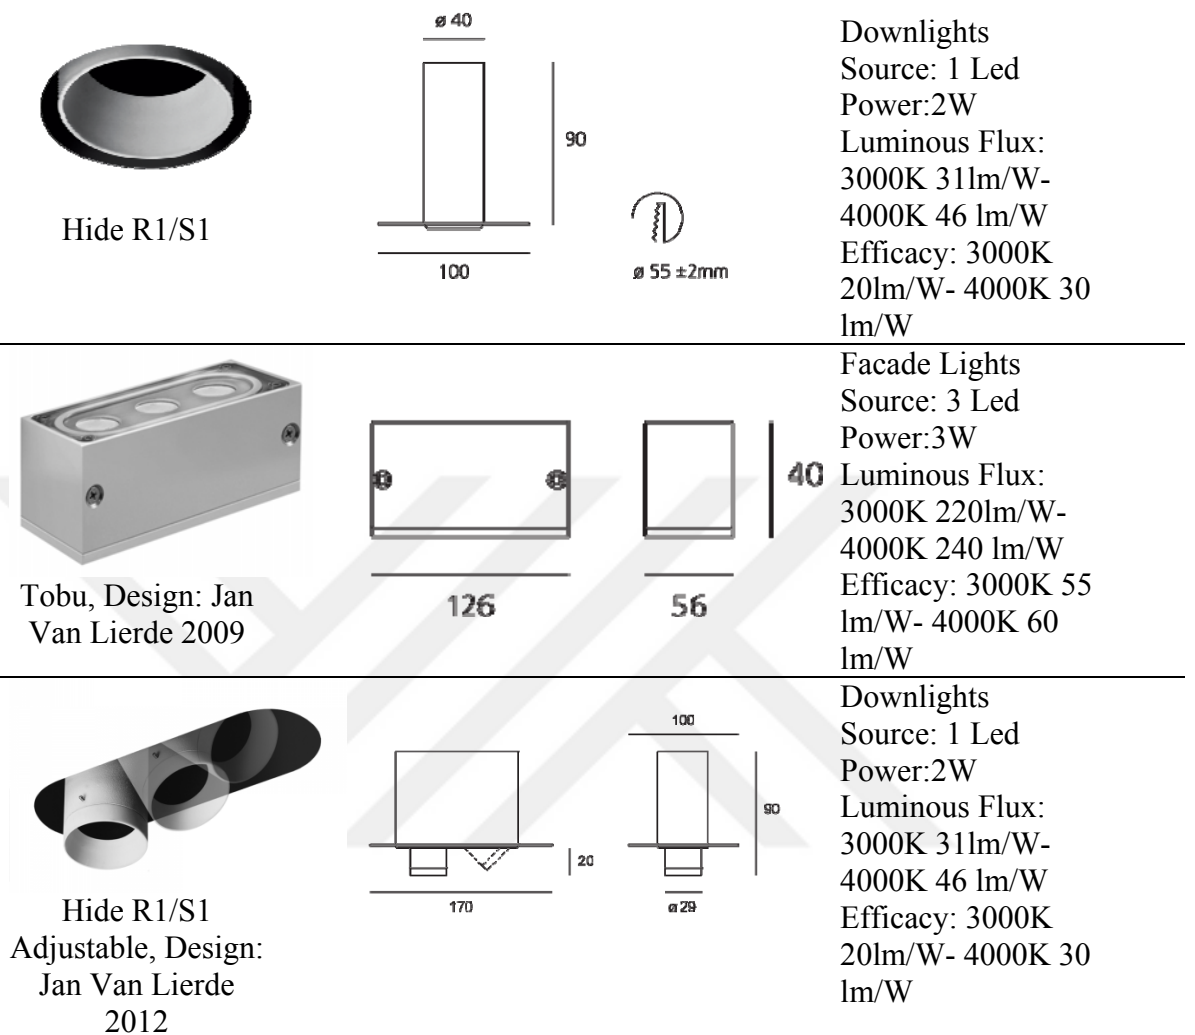
**Figure 3.49** Lighting elements used in Salt Beyoğlu (Url-12)

In addition to the architectural features, the project also saw the study of proper lighting through the work of the architect Jan Van Lierde, who worked on the light in the interior and exterior spaces (see Figure 3.49). The design of the exterior, realized with projectors Tobu wall of small dimensions, effectively enhances the essential details of the facade, and through the use of specific optical effect gets strong intensity.

Inside, LED products of the series Hide are used in various areas, including for example the multi-purpose hall inside the building, that allow the creation of an even completely hidden luminaire, turning the light emitted in the only real protagonist of the scene. In particular, the product Hide is adapted to the various types of existing building ceiling, drywall or structure type Armstrong, through specific mounting accessories (Url-11).

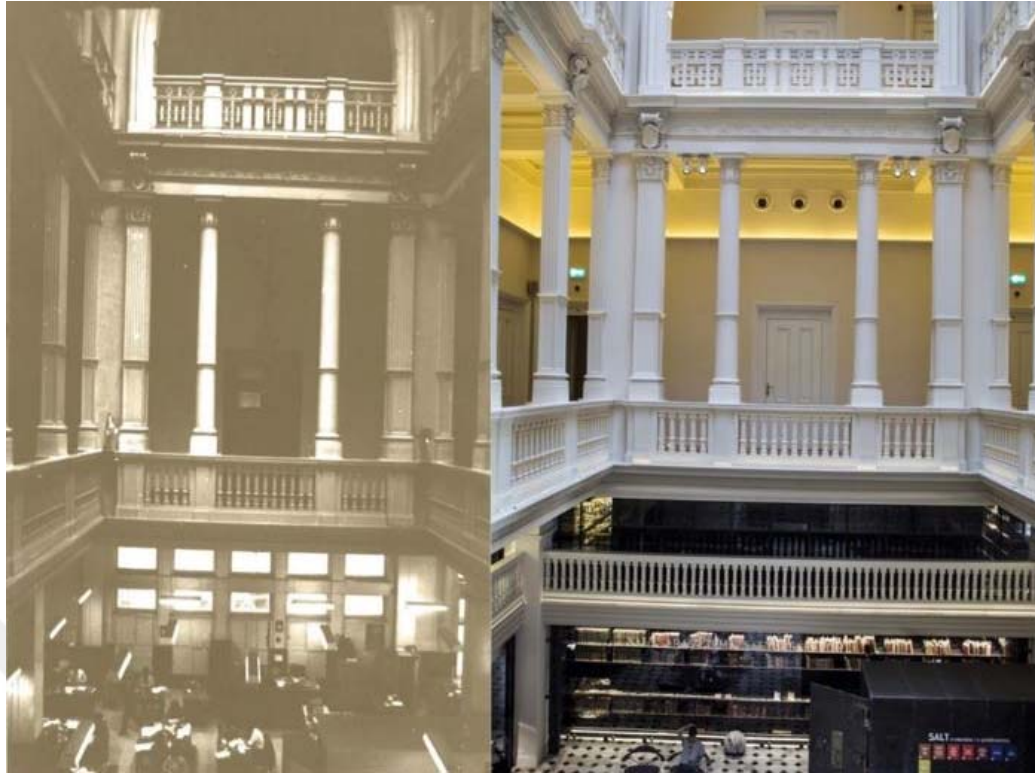
**Figure 3.50** Courtyard old new

Salt Galata (2011) in Bankalar Street is today's description of Ottoman Bank (1892) in Voyvoda Street (see Figure 3.50). Garanti Bank has the following article in its web site for the architecture of culture institution which makes programs in many fields from architecture to design and city life, from daily life to social history and economy history.

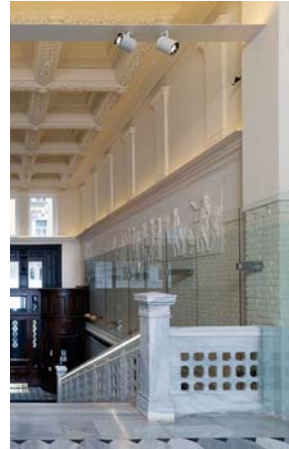
**Figure 3.54** Glass display at the entrance scene of Salt Galata

One of the significant innovative design decisions is that the archeological wall decorations on the entrance were reflected with glass display.

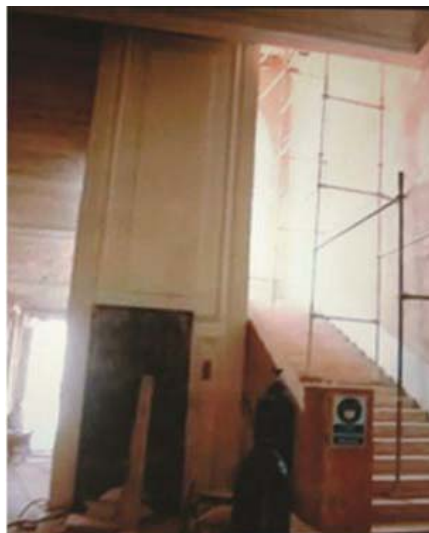
**Figure 3.55** Elevator used in the Ottoman Bank [28]

The section which is used as elevator hall today was used as room in the 19<sup>th</sup> century. There was an elevator on the staircase space between ground floor and first floor opposite the entrance (see Figure 3.55). Removal of this elevator used in the old structure was one of the most significant design decisions. As result of removal of elevator, staircase was reflected more, as one of the valuable elements of historical place. In addition, sunlight entering from large window starting at the staircase was made available for the users until the main entrance (see Figure 3.56).

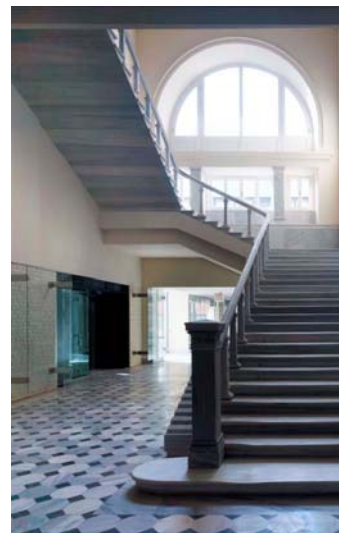
**Figure 3.56** Large space created by the removed elevator

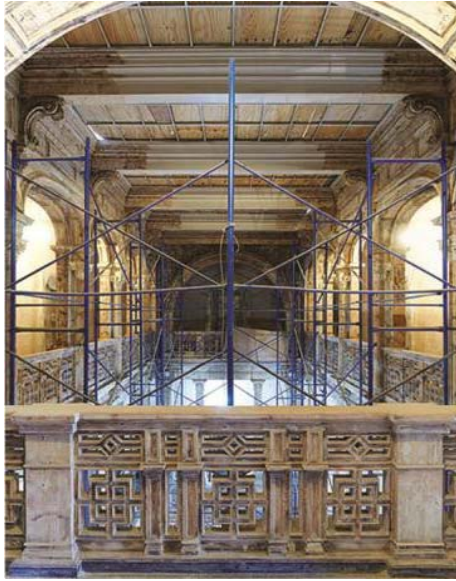
**Figure 3.57** The gallery space started to block sunlight

Gallery space, starting from the ground floor in main building, was closed as result of the changes made until today (see Figure 3.57). Its relation with sky was cut. Firstly, original sunlight was taken back in the building by removing the additions blocking sunlight. Then the layers on decorations within frame were removed and original wooden layers were reached and painting was made on these layers (see Figure 3.58). Finally, energy saving was made by using Heliostat panels for compliance with future (see Figure 3.59). With the help of this mirror and glass panels, maximum sunlight was transferred to the middle of building in the most economical way.

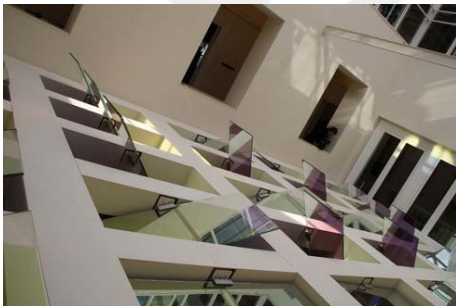
**Figure 3.59** Salt Galata's mirror panels (heliostats)

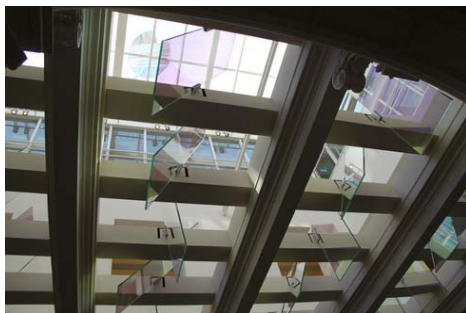
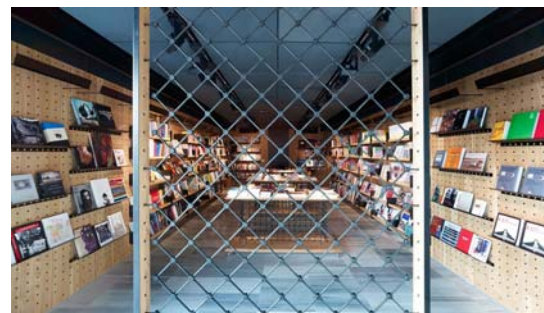
**Figure 3.60** Bookstore of Salt Galata

Due to the size and diversity of the structure, new spaces will be examined by considering in parts. In this review, firstly the bookstore on the ground floor of new building will be considered. A flexible system was made by considering sales and display conditions by using metal and wood (see Figure 3.60). Every element consisting a part of the system within the store has created an integrated design by allowing different uses of store (Url-14).

Link (the product created by Omer Unal) which can be made in different shapes with different connection styles, has taken a form in which books are displayed and all shelves can be repositioned according to their heights. Integrity of natural wood that can be applied on the ceiling and basement with black and grey tones gives a balanced, modern and warm view to the place (Url-15).

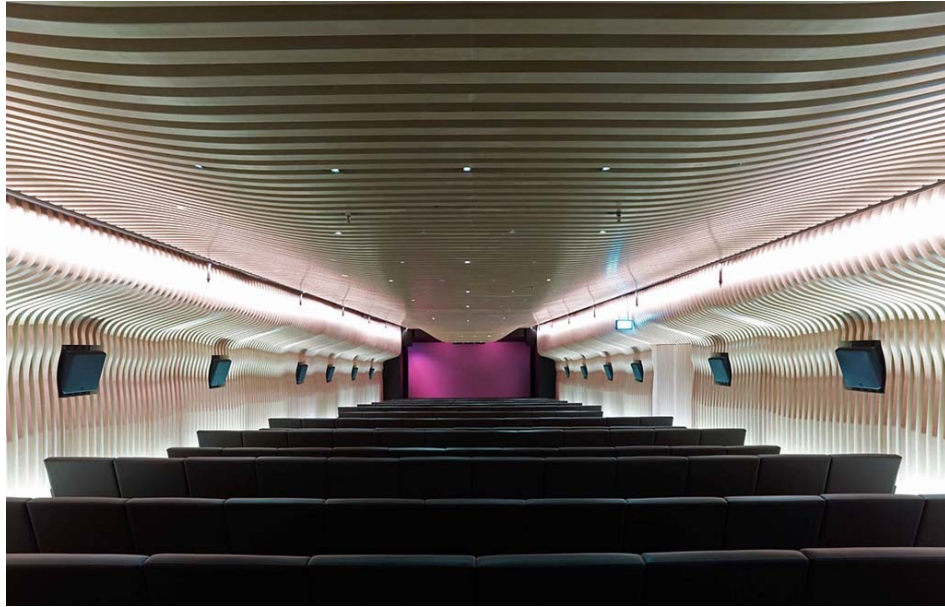
**Figure 3.61** Drawing of auditorium

Auditorium, which is located on the 2nd basement floor of additional building, was designed by Zoom TPU for classical presentation and sharing events as well as long term sessions, discussions, seminars and conferences. Auditorium with a capacity of 129 people can also be used for performances. Wood was used commonly in place arrangement and leather was used in seating units. Irregular wall surfaces were created with wood records drawing different curves in short intervals with in order to ensure necessary space for acoustics (see Figure 3.61). Technical requirements such as mechanical, electrical and lighting were created behind the wood surface. Place, which has been integrated with the ceiling having same materials and approaches, gives the view of an eardrum and an organic view such as a cave (Url-14).

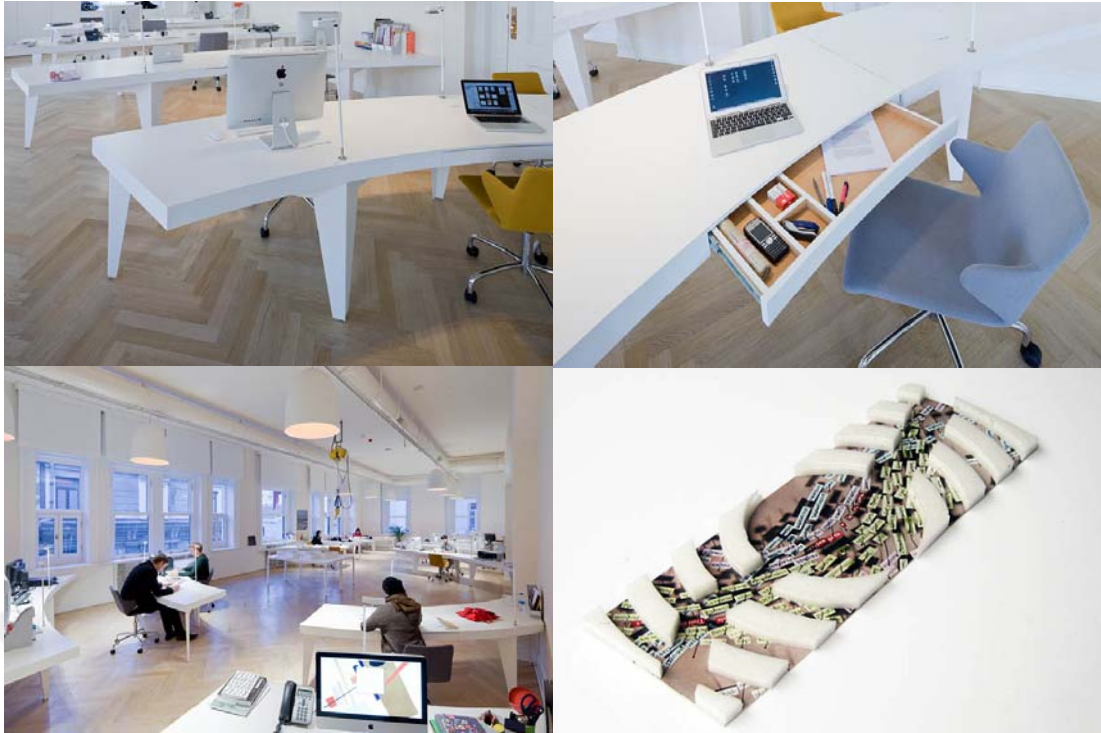
**Figure 3.62** Salt Galata's office designed by Superpool

Offices are located on the facade facing Bankalar Street on the second floor. Starting from the organization's "innovative programs on experimental drops and researches", design named "Parliament" reminding a large meeting hall with empty space in the middle was applied. Elliptical tables, which allow synchronous little meetings with individual works, allowed clustering around. "Parliament" which allowed presentation and discussions reflected Salt's collective thinking, discussion and creation understandings. Tables in offices designed by SUPERPOOL can be used from both sides in such manner that they provide flexibility in the place. Lighting and electrical equipment were located within the tables with 8 cm of thickness. Durable and simple white Formica was preferred for the surface. Inner sides of drawers were coated with oak (see Figure 3.62).

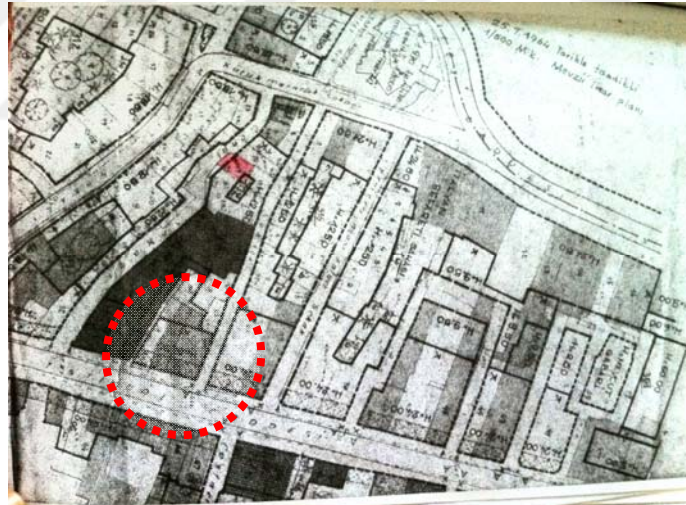
**Figure 4.4** Site plan of parcel belonging to 1964

1 / 500 - 1 / 200 layout plan (Figure 4.4)
