**RENOVATION AND RECLAMATION OF OLD BUILDINGS IN  
İSTANBUL: THE CASE OF BORUSAN MUSIC HOUSE IN BEYOĞLU**

**A THESIS SUBMITTED TO  
THE GRADUATE SCHOOL OF NATURAL AND APPLIED  
SCIENCES OF  
ÇANKAYA UNIVERSITY**

**IN PARTIAL FULFILLMENT OF THE REQUIREMENTS FOR THE  
DEGREE OF  
MASTER OF SCIENCE  
IN  
THE DEPARTMENT OF  
INTERIOR ARCHITECTURE**

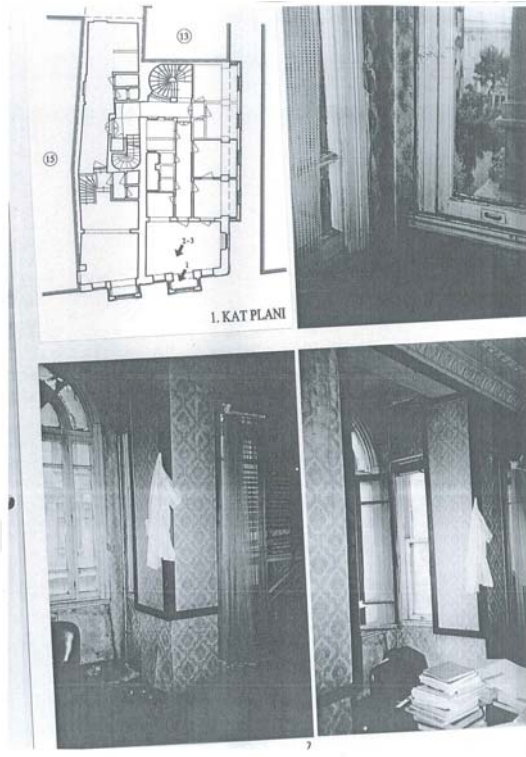
**Figure 4.6** Photos of the old first floor

In general, floor mats of rooms and living rooms of houses taking place on first floor and typical floors are wooden, their walls and ceilings are plastering (Figure 4.6). In addition, floorings of kitchen and bathrooms of these flats are specified as ceramic, their walls and ceilings are specified as plaster.

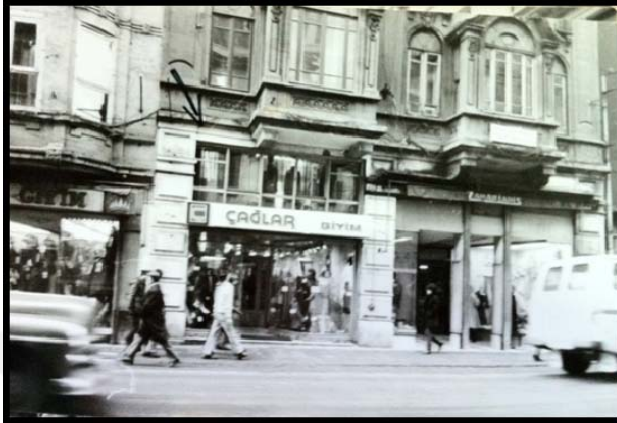
**Figure 4.8** Two front entrance of ground floor

different entrance located in front of the ground floor were at the same place but they were used as clothing store instead of restaurant (Figure 4.8). Entrance located at the facade facing OS is opened directly to upstairs (Figure 4.9).

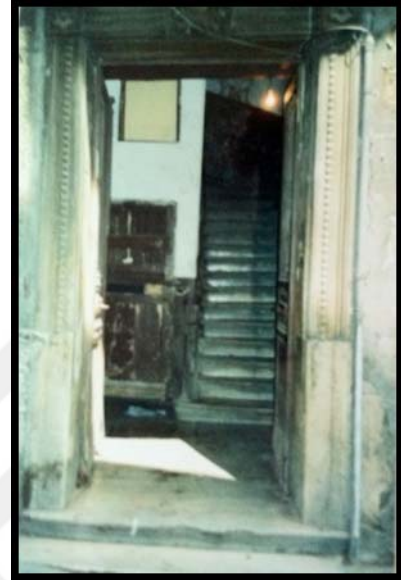
**Figure 4.9** Side entrance of ground floor

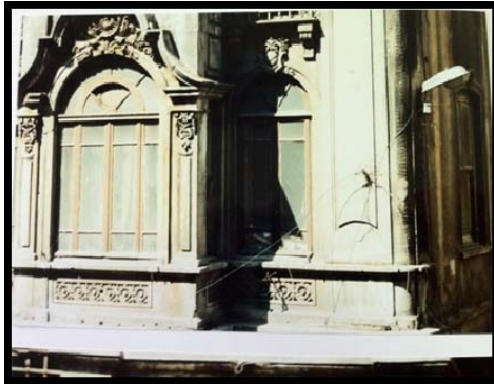
**Figure 4.10** Stone archs of 1<sup>st</sup> floor

First floor: Arched windows are located on this floor. Ornaments of the arched windows are made of stone (see Figure 4.10). Ornaments of two of these five arched windows taking place in the facade of this floor were made flashier than the other three. As figure, leaves have been used on the branch. On the smaller arch ornament, figure of leaves have been used with curved motifs (Appendix 19). Windows on this floor are wooden joinery as other windows on the other floors. The feature of the joinery on this floor differentiating from the other joinery is that wooden joinery has been made inclined in accordance with the arched structure. Other ornaments of this

floor are the flower figures inside the rectangular stone frames in the bottom of each window. Flowers in the frames have taken place in surveys as stone ornament.

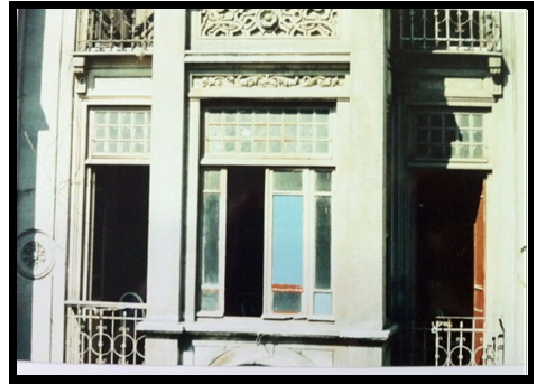
**Figure 4.11** French balcony of 2<sup>nd</sup> floor

Second floor: At this line, there are three decorative patterns, round-based stone ornaments on stone columns. In the three of five windows, there are French balconies. Railings of the balcony are made of iron. Circle and fold patterns have been used as pattern. There are two stone mutules under each railing, one in the left corner and the other in the right corner. In the patterns of woodwork windows, there are square grids (Figure 4.11).

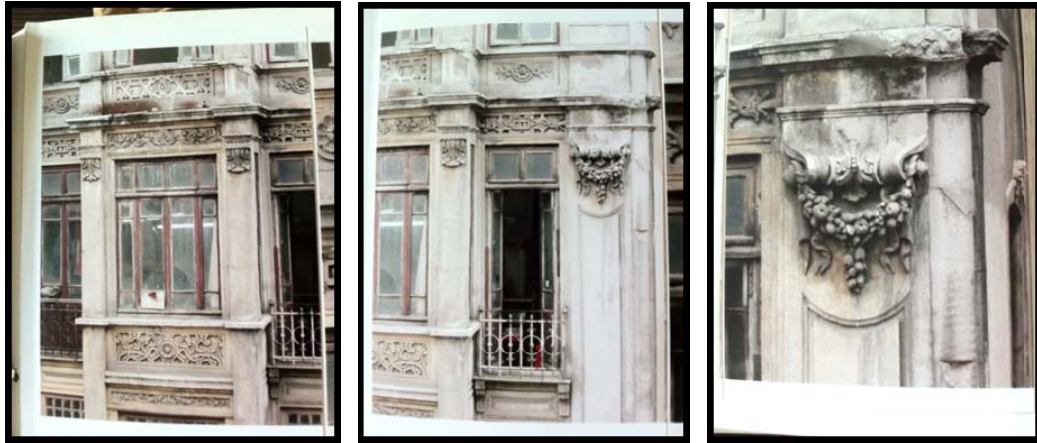
**Figure 4.12** Grape ornaments, simplified wooden window frames

Third floor: There are curled ornaments resembling bunches of grapes on stone columns on this line (see Figure 4.12). On this floor, there are also French balconies same as with the French balconies in the second floor (Appendix 20). Woodworks are simplified on this floor. Flower and leaf patterns have been combined with curves in rectangular stone window frames above the windows. Stone moldings, which have been seen between ground floor and first floor, are also seen between third and fourth floor.

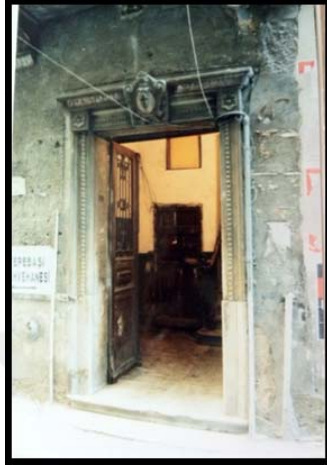
**Figure 4.13** Ground floor facade facing OS door

Ground Floor: There are three big windows and one door. The door has been made of iron and surrounded by a marble jamb (Figure 4.13). At the upper middle part of the marble jamb, there are decorative curved pattern and flower patterns on their upper corners (Put figure-detail). Visual contact of windows with street is blocked by shutters (see Figure 4.14). In the two of three windows, there are plastered jambs.

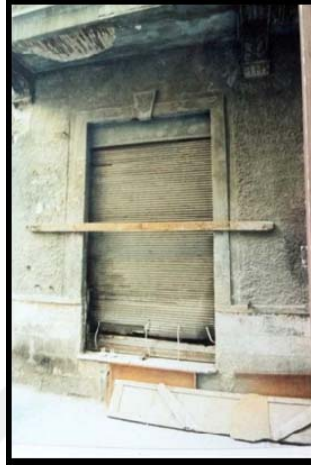
**Figure 4.14** Ground floor facade facing OS window

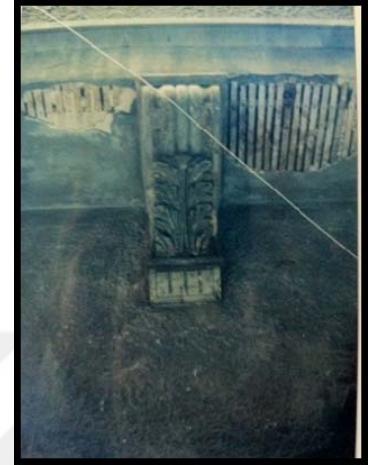
**Figure 4.15** One of the mutule

On upper mid-point of these simple jambs, there are rectangular ornaments which are also taking place at the fifth floor of facade. There are five wooden mutules at the ceiling line (Figure 4.15). Stone molding, which continues lengthwise on it, is seen (Appendix 14).

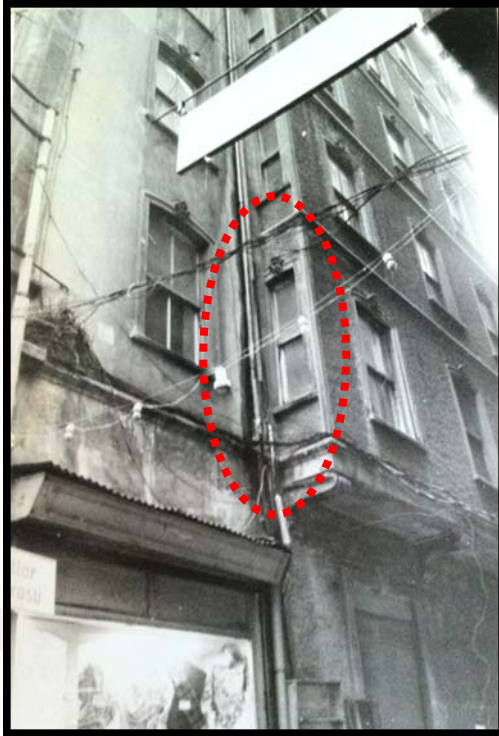
**Figure 4.16** Narrow windows of facade facing OS

First, second, third, fourth and fifth floors: There are 6 windows in each of these floors. Five of them see the facade facing OS and a narrow one sees İstiklal Avenue (see Figure 4.16). This narrow place takes place after the first window looking facade facing OS and cannot be seen in summer frontage drawings. All windows have been made of wooden guillotine, their jambs have been covered by plaster, their upper lines have been designed mild curved and there is a small stone ornament in the center of this curve (see Figure 4.17). At the transition line of this qatar, stone molding continues lengthwise.

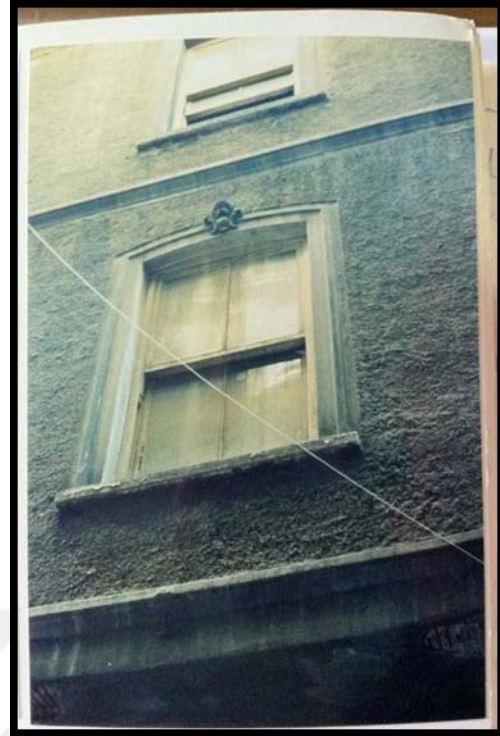
**Figure 4.17** Windows of facade facing OS

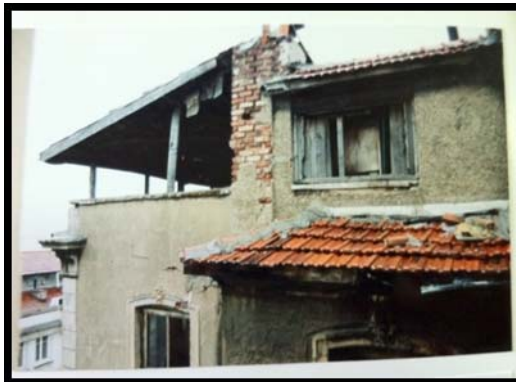
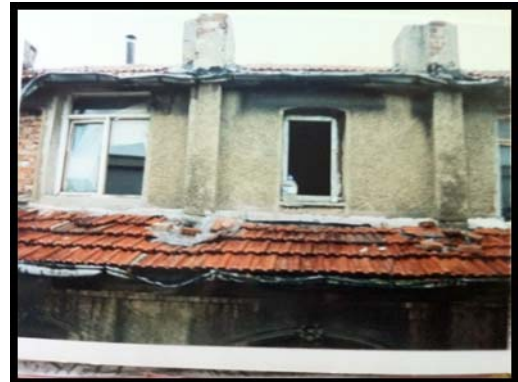
**Figure 4.18** Photo of old loft from facade facing OS

Loft: There are three windows. Windows are woodwork and far from ornament. The walls are covered with plaster (Figure 4.18).

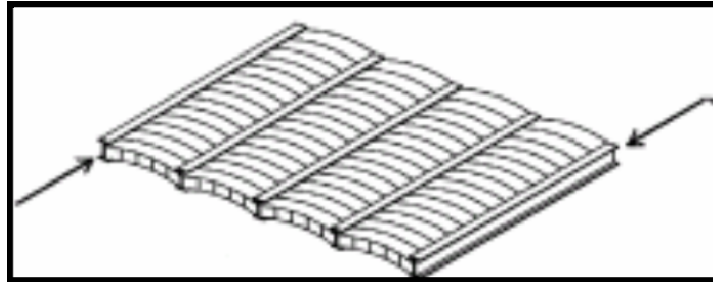
**Figure 4.19** Floor arch [35]

Floor arch is a type of upholstery which involves construction of brick vaults between steel I profile beams which operates in a single direction (see Figure 4.19). It transfers vertical loads to brick vault arches. Brick vault arches transfers the same to steel girders. And steel girders transfer it to walls on which they were built or columns. Steel profiles can slide under horizontal earthquake loads. Brick arches may be weakened by bending perpendicular to its plane or bending in its direction; there may be dynamic interaction between steel girders and brick and system does not show a diaphragm operation [35].

Connecting I profile girder ends with vertical girders, or establishing I profiles that will create grids between I girders increases the seismic strength of conventional floor arch. Roofs and floorings of historical masonry structures have been made by vault or cupola. These curved surfaces are quiet stabile if impact forces in their braces are adequately met [35].

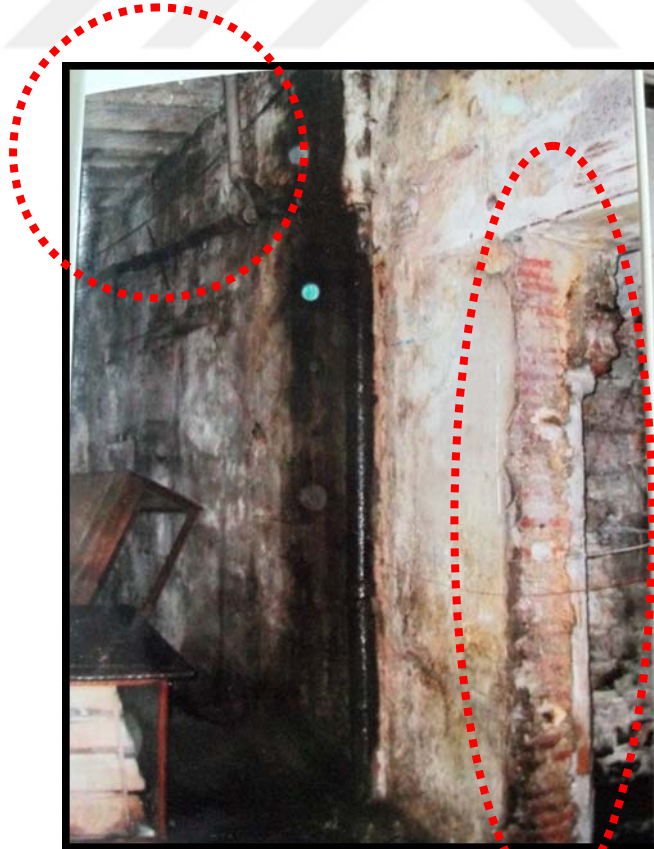
**Figure 4.20** Ceilings of ground floor and walls are masonry brick

Ground Floor: Walls are masonry brick walls. The ceiling is likely to be completely floor arch, but it is not certain due to fact that it couldn't be documented (Figure 4.20). In the former form of the structure, there are documented floor arch drawings. First of it is on the fifth floor, in the space corresponding room below the terrace (see Figure 4.21). Secondly, it is shown in the kitchen on third floor (see Figure 4.22). Final documented floor arch is in the warehouse space of ground floor (see Figure 4.23).

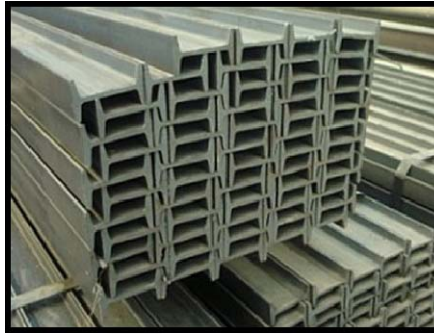
**Figure 4.24** Joists

Joist means iron girder connection (Figure 4.24) (Url-19).

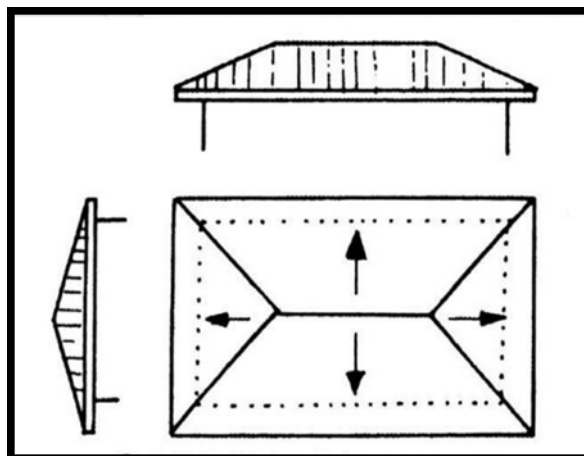
Figure 4.27 Hipped roofs

Hipped roof is in the form of roof having flow in four directions [36]. These are roofs which have inclined surfaces as edges of the building on which it was built (Figure 4.27).

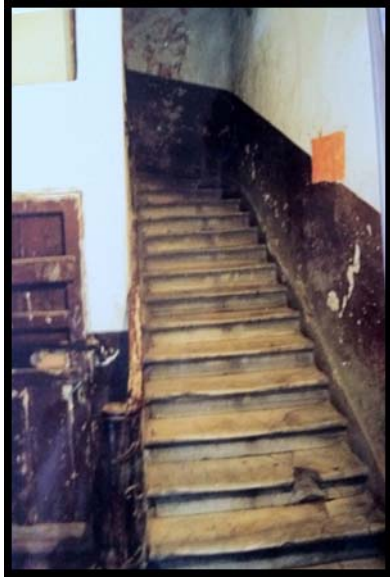
**Figure 4.28** Old stairs are marbled

Flooring of warehouse located at ground floor consists of tile, their walls are plaster and their ceilings are timber. Stairs, beginning on the ground floor and providing main vertical circulation of the structure, are marble covered on stone (Figure 4.28).

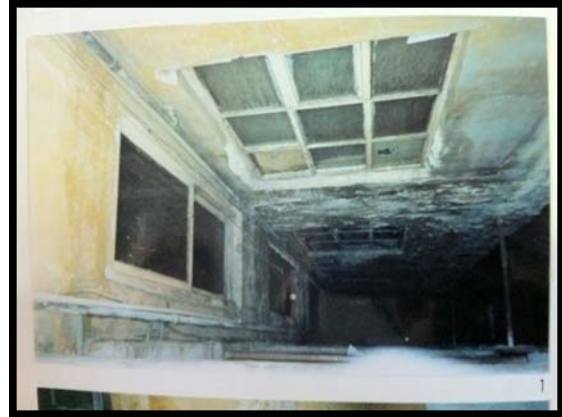
**Figure 4.29** Photo taken from loft, natural lighting well

Lightings in the structure are divided into two as natural and artificial. One of the natural lightings is daylight entering into apartment from skylight. The other is lighting entering from bright field and providing light to remaining rooms and kitchen in the interior parts of flats (Figure 4.29). Lights of luminous are provided by daylight taken from the gaps of roof.

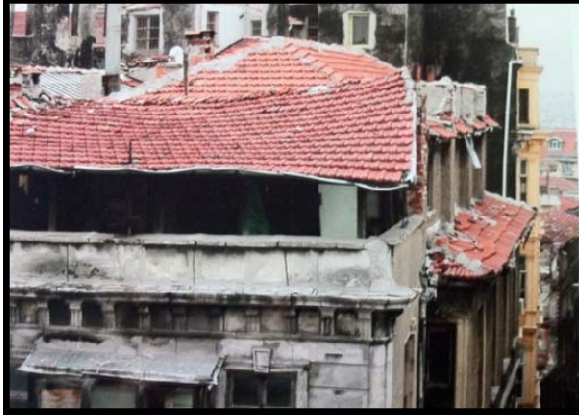
**Figure 4.35** Marseille roofing tile has been used in roof. The roof is in the form of hipped roof

Artificial lights emerge at two visuals. In one visual, we see hanging light used in the corridor (see Figure 4.30). On the other, we see the light bulb used in well (Figure 4.31). Ceramic types used in the structure can be seen in the following images in details. Glazed tile is seen in Figure 4.32, sequentially ordered white ceramic is seen in Figure 4.33 and obfuscatory installed brick color square-shaped ceramics are seen in Figure 4.34. Material used in the roof is Marseille roofing tile (see Figure 4.35). It is floored with ranking system as can be seen in Figure 4.36.

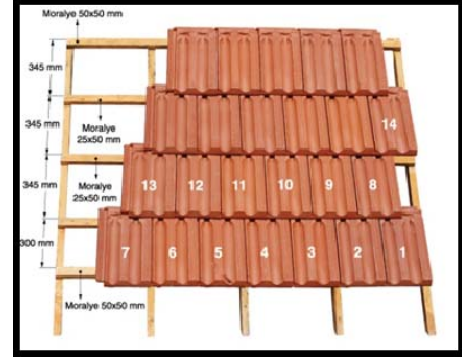
**Figure 4.36** Marseille roofing tile has been used in roof

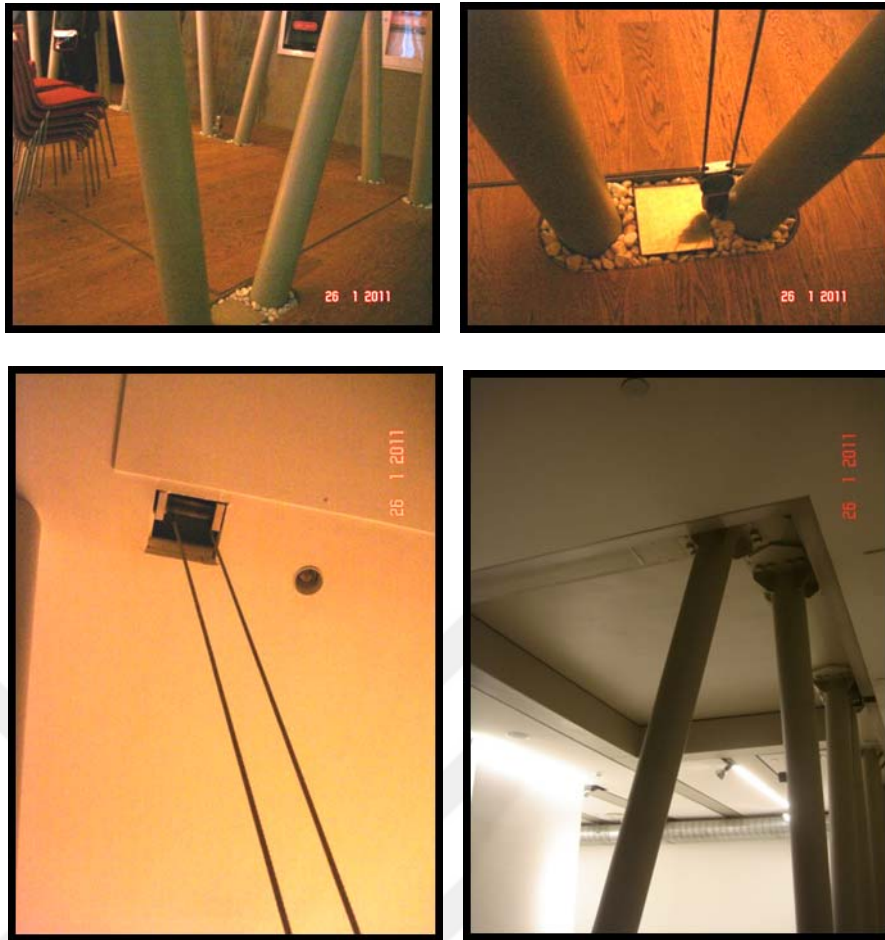
**Figure 4.43** Piano elevator system between 1<sup>st</sup> and 2<sup>nd</sup> floor

Between floors, a different design providing link between floors attracts the attention. First of these is the piano elevator (Figure 4.43). It completes its function as a result of a rectangular piece is sat on the ground of first floor by separating from the ground of second floor. It is realized with wrapping movement of mobile steel rope. Other different design of this connection between these two floors is a thin, long, rectangular glass surface located in parallel with stairwell which also takes place both in the ceiling of 2<sup>nd</sup> floor and ground of 3<sup>rd</sup> floor (Figure 4.44). From this point, it becomes possible to capture clues about the structure of building for people who see the building for the first-time.

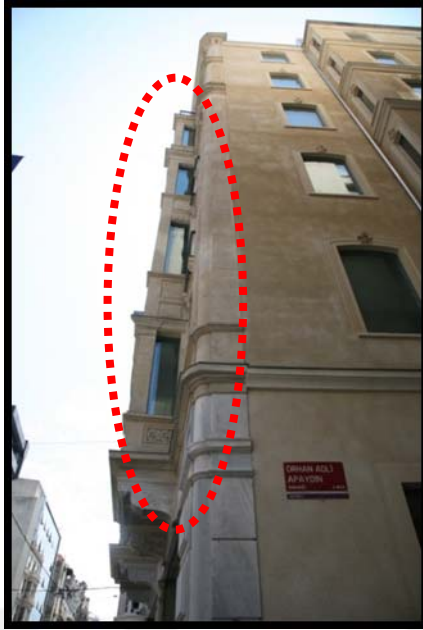
**Figure 4.49** New facade and facade facing OS

Facades of the building have been renewed faithfully to exterior features described in section 4.1.3.2. However, adaptation styles of both two frontages to present were different. Facade has been restored and moved to the present day. Facade facing OS was demolished and rebuilt in an appropriate manner (Figure 4.49).

Although blind frames are predominate, in new building there are also opening windows. Opening windows are located in terraces and heads where facade extends (Figure 4.49 and Figure 4.51). A photo from the constution process of windows located in terrace is seen in Figure 4.52. These windows are opened to a semi-outdoor place (see Figure 53). There are two openable door joineries on facade. First of it, is the double wing door on the front side. This door has a feature distinguishing it from others. This door has remained from the former form of the building. This old and unusable door has been used in new building with repair (Figure 4.37). Second opening door is located on the 5th floor of facade and opened through the balcony of the building. This door has been rebuilt as other joineries on facade.

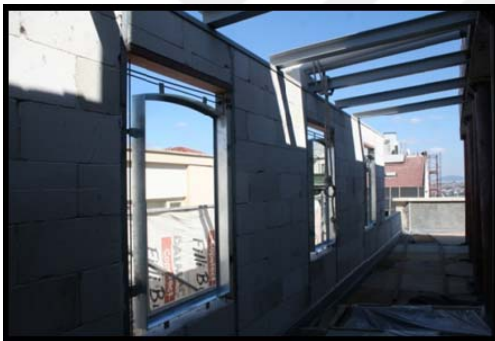
**Figure 4.52** Four openable joineries for terrace construction photo

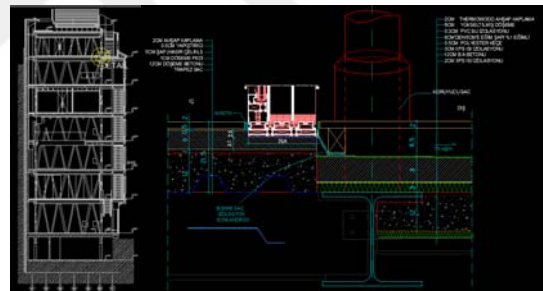
**Figure 4.54** Sliding joinery detail on loft

Another joinery detail on the loft is used as facade on terrace. So, access to terrace can be provided by a door opened from this front. This door was designed as sliding door so more usage area has been created in terrace (Figure 4.54).

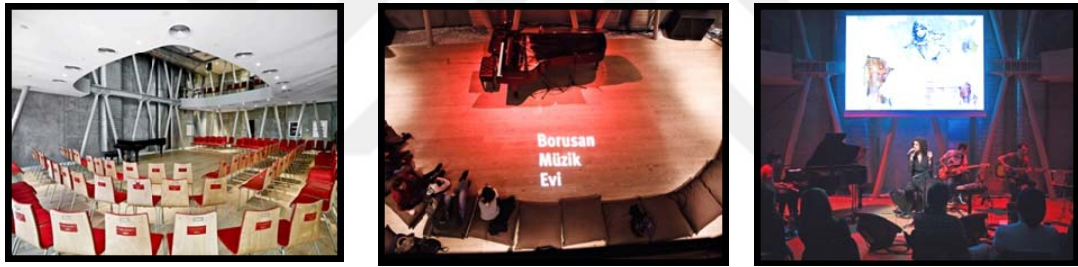
Seating order with chairs

Seating order with cushion

**Figure 4.55** Seating orders with different alternatives

Since from the restoration project, no significant modifications/amendments have been carried out in BMH. Changes in the new version of the building are formed in accordance with the needs of carried out events. Number of person required for the event determines the form of seating order. Seating order with cushion is preferred for the events performed for young people, seating order with chair is preferred for the events performed for protocol and seating order with tables is preferred for the events performed for less number of participants (Figure 4.55). Seating plan with tables for 40 people in 2011 was increased to capacity with 17 tables, in which 4 people will sit, for 68 people in 2014. In 2015, a new settlement plan has been arranged for 182 people with more significant border (Figure 4.57). If the event is exhibition instead of concert, elements to be displayed instead of seating units are settled.

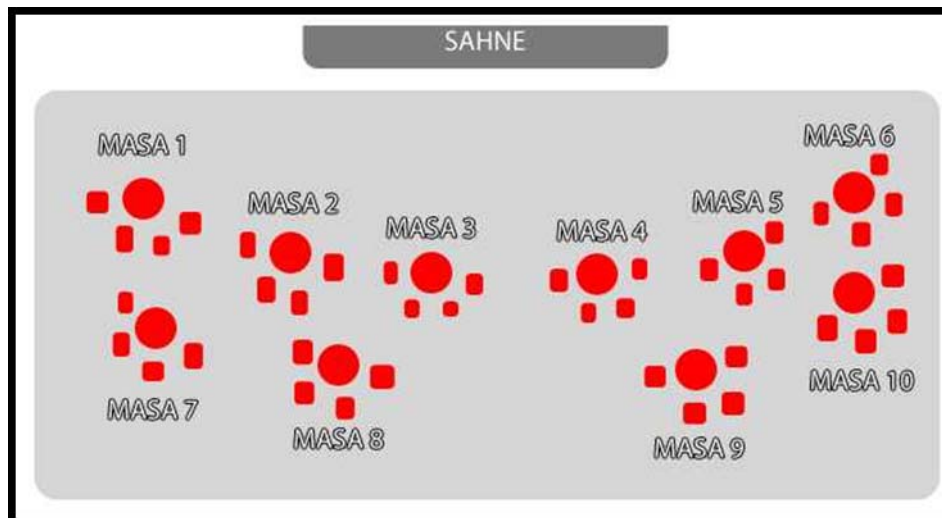
Figure 4.56 Seating plan with tables for 40 people

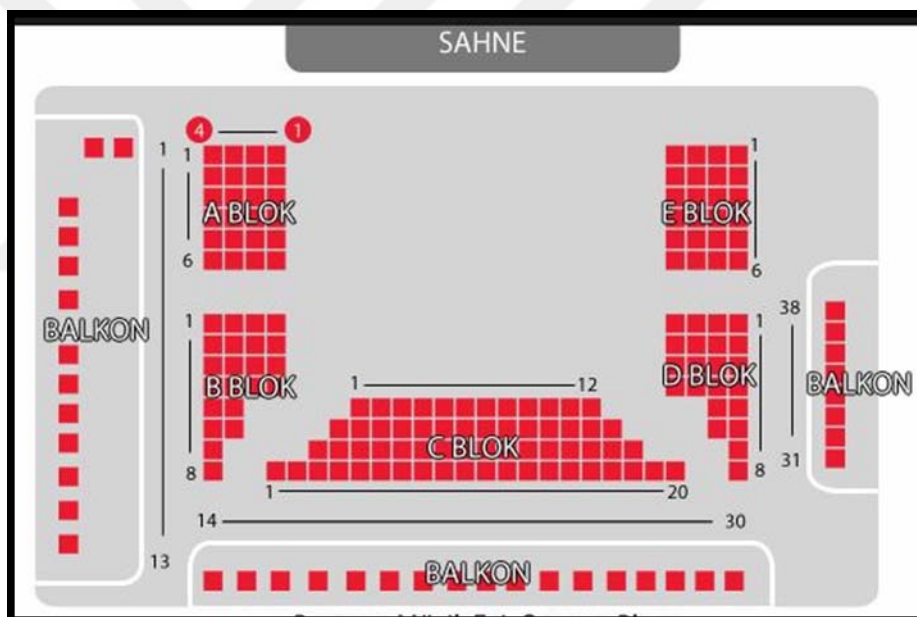
Figure 4.57 Borusan Music House eating plan for 182 people

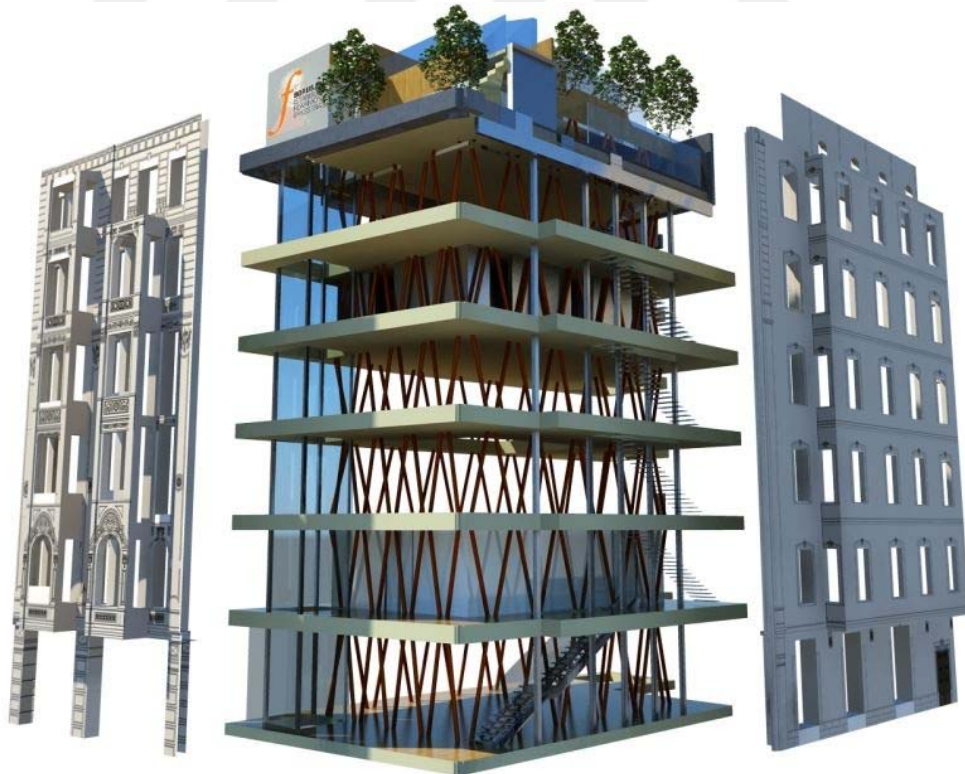
**Figure 4.58** Structural system model of BMH

Vertical Building Structure: Diagonal steel structure is the system which carries out the main load of building (Figure 4.58). This system, which is the vertical carrier due to its shape, also resist against lateral loads. From ground floor to loft, this system continues. Structural system on the borders of building is I steel columns (Figure 4.59).

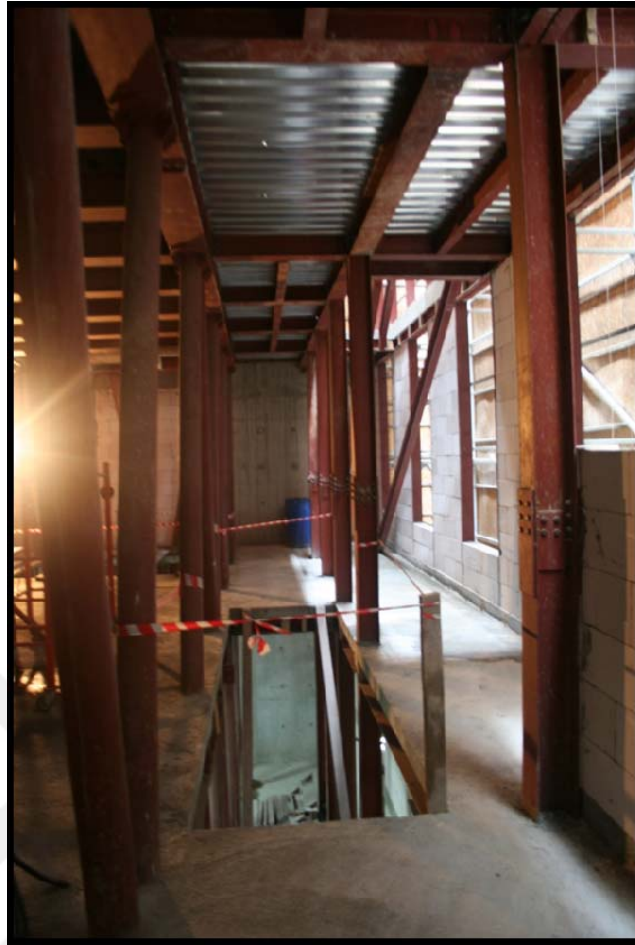
**Figure 4.59** Diagonal steel structure is seen on the left side, I steel columns are seen on right side, gas concrete blocks are seen on right front, steel right profiles used in horizontal are seen at the top

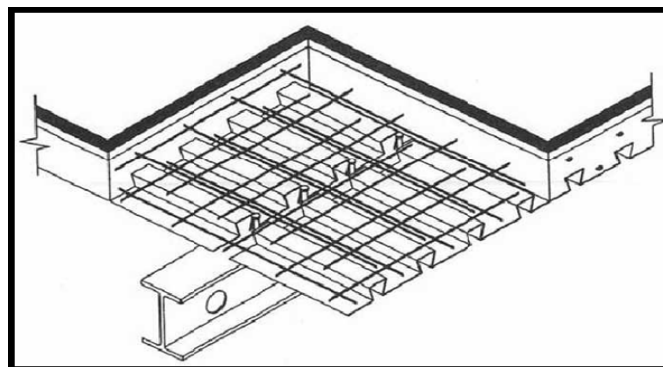
During construction, it should be completely settled and combined with steel girders in order to have qualification that can carry wet concrete to be poured onto steel sheet. For the correct replacement of dry concrete, pouring type is important. For correct replacement, at first concrete should be poured on structural bearing elements, then process should be completed by advancing towards the center of sheet gap [38]. In this way, concrete is uniformly distributed throughout sheet gap. Uneven distribution of casting will cause the problem of concrete ponding. Another problem is the possibility of corrosion of the steel sheet. In order to prevent corrosion, it is necessary to take measures before concreting. All kinds of impurities on the steel sheet should be cleaned. This cleaning not only prevents corrosion but also have qualification as preliminary during the seaming process of sheet and steel girder. Moisture can cause seaming defects as well as corrosion. Therefore, during seaming process, steel sheet should be dried by compressed air to eliminate the moisture on steel sheet [38].

**Figure 4.60** Steel sheet-concrete composite flooring

Composite floorings, which are constituted with profiled steel girder, sliding connection, steel sheet and concrete composition, have many structural and economic advantages compared with traditional floorings: Girder gap can reach up 9-12 meters and girder range can reach up 2.5-3 meters [38]. Before concrete pouring, steel sheet creates a safety platform accelerating construction time for other processes. It acts as permanent mold for concrete. Less height of steel sheet provides concrete economy up to 40 liters/m<sup>2</sup> depending on type of sheet. This reduction in own height of flooring provides a significant reduction about 1.0kN/m<sup>2</sup> in dead load carried by building and foundation [38] (Figure 4.60).

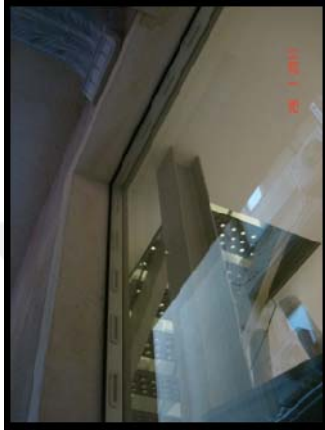
On the facade of ground floor, there is a tempered glass made by using the entire distance between columns and girders of the building. This glass is shatterless and has noise insulation features. This glass on the entrance has ability to get daylight in maximum level. In addition, with the decision of this glass material, it is in the qualification inviting people walking on İstiklal Street to the event in the space whether they don't enter. Single big windows on facade facing OS accompanies to the transparency on the facade of first floor. Infrangibility and soundproofing features of these double layered windows become the priority of preference (Figure 4.61). While three big front windows carry daylight into the building during the day, at night they bring artificial lights of the building with people walking on the street.

**Figure 4.61** Ground floor, facade facing OS single piece double glazing

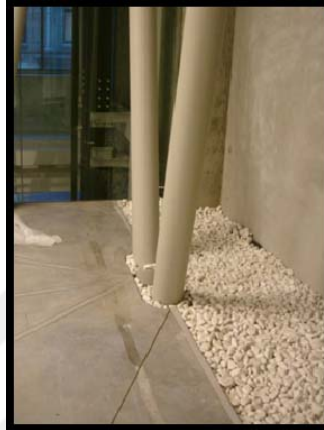
On the ground floor, floor covering of area, in which there is a permanent exhibition, is industrial floor covering concrete looking epoxy (Figure 4.62). Moreover; decorative pebble stone has been placed on spaces between column and wall.

**Figure 4.62** Ground floor, first floor and terrace flooring material

Concrete looking epoxy has been used as ground material on first floor. On the ground, decorative pebblestone has been placed on bottoms of column and spaces between column and wall (Figure 4.62). On interior wall of facade, there is brick looking natural covering which was renewed faithfully to former form (Figure 4.64). Lateral front walls with windows are acoustic gypsum panels with dispersed holes. Windowless wall, adjacent to neighboring building has been covered with exposed concrete looking implementation (Figure 4.65). Ceiling is a white colored suspended ceiling. Artificial lighting of first floor is provided by a white fluorescent inserted into this suspended ceiling (Figure 4.66).

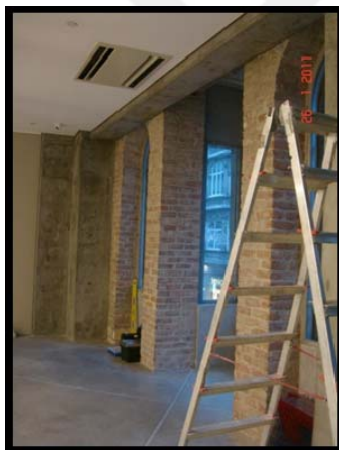
**Figure 4.64** Floor material of first floor is concrete looking epoxy

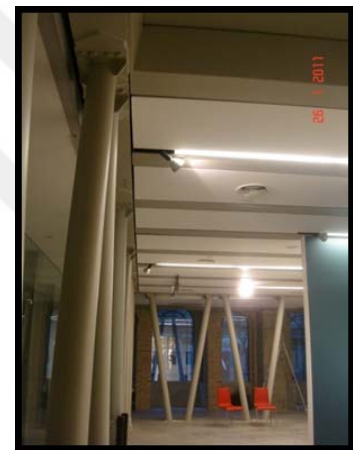
**Figure 4.66** Ceiling and lighting on first floor

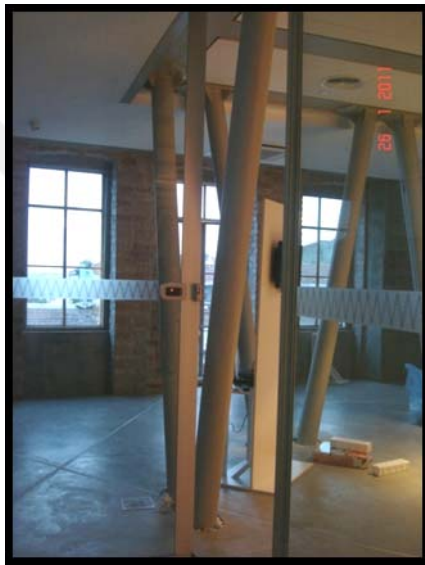
**Figure 4.67** Fifth floor entrance is provided by card system

Grounds of fifth floor and terrace are concrete looking epoxy as industrial floor covering (Figure 4.67). Wall materials are same as other floors. Ceiling of the fifth floor shows similarities with first floor. On the ceiling of terrace floor, black suspended ceiling has been used. Unlike from the other floors, there are big windows

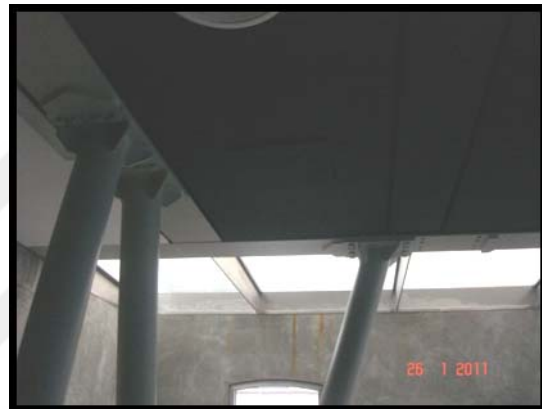
**Figure 4.68** Terrace skylight

on the ceiling of terrace which have been located to see the sky (Figure 4.68). These provide the entrance of daylight to space directly. Artificial lighting of these floors has been provided by downlights.

Glass panels taking place next to interior stairs divide space without interrupting the image. These panels act mainly as parapet for stairs. So, individual moving between floors by using stairs can see all floors one passed. Through glass panels, both safeties are provided and daylight can enter into space without any decrease. Glass panels continue from ground to ceiling. Detail drawing of panel on ceiling is shown in Figure 4.72 and detail drawing on ground is shown in Figure 4.73. Upper part of glass panel is combined with suspended ceiling and lower part of it is combined with wooden flooring. 30x120mm aluminum box profile has been used on ceiling and 30x40mm aluminum U profile has been used on ground. Glass used in panel has been formed by combination of 6mm 2 laminate glass. Unlike other floors, card sliding door system is added to these glass panels on 4<sup>th</sup> and 5<sup>th</sup> floors. Due to fact that 4<sup>th</sup> and 5<sup>th</sup> floors are spaces designed for the use of employees except guests, these doors were needed. Card door systems are for preventing the entrance of both undesirable individuals and undesirable sounds of other floors (Figure 4.68).

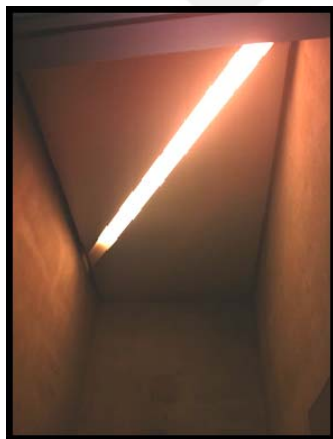
According to information taken from plans, there are restrooms on each floor, but it has been determined during the inspection that there aren't any restrooms on 2nd and 3rd floors. The flooring of the restrooms is orange colored epoxy (Figure 4.39). On walls, concrete looking coating on green gypsum panels has been applied. The ceiling is gypsum panels. Lighting has been resolved on this gypsum panels (Figure 4.69).

**Figure 4.69** Restroom ceiling lighting

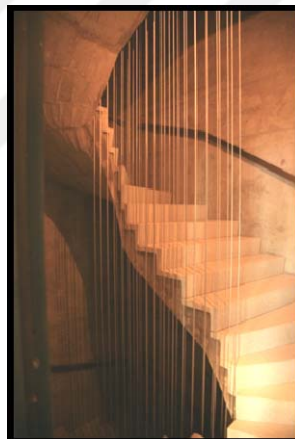
**Figure 4.70:** Fire escape

Fire escape continues uninterruptedly from -1<sup>st</sup> floor to terrace at the same axle. There is exposed concrete implementation on its walls. Steps of stairs have been covered with concrete colored stone. There is a metal handle on the wall side. Instead of metal railing, stainless steel ropes have been used through floors (Figure 4.70). Elevator continues uninterruptedly from -1<sup>st</sup> floor to terrace at the same axle. Square elevator is made of glass material. Railing inside it and parts of electrical components are stainless steel. Due to fact that area, to where elevator ending at

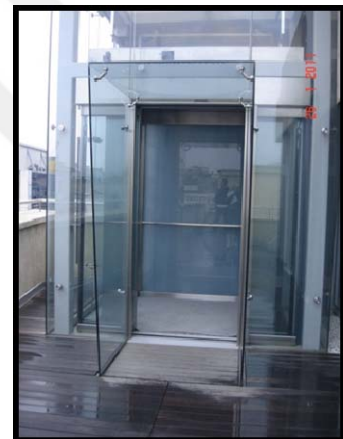
**Figure 4.71** Elevator door at terrace floor

terrace goes, is an open space; glass raincoat has been added to elevator exit door (Figure 4.71).

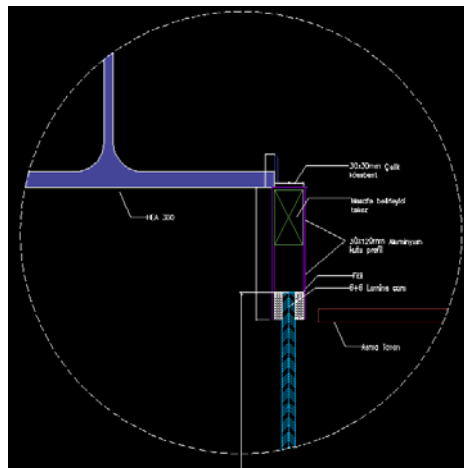
**Figure 4.72.** Separator glass panel detail taking place in the space

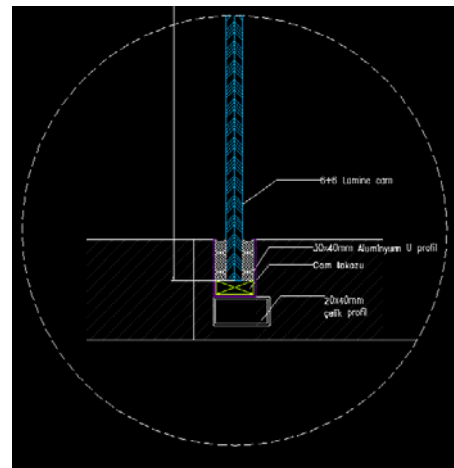
**Figure 4.73.** Separator glass panel detail

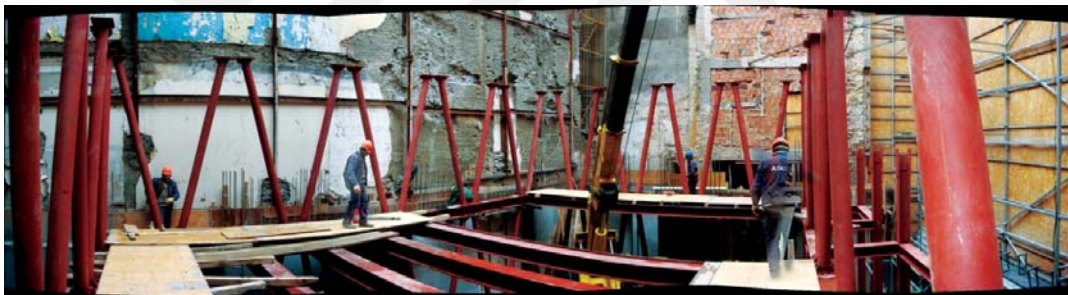
**Figure 5.1** Photographs of the construction phase as taken by GAD  
(GAD, February 2008)

It is seen on the photograph that nothing was left out of the old building except for the front facade in February 2008 (Figure 5.1). Frontal facade was supported by steel elements which kept it standing (Figure 5.2). Since the previous load bearing

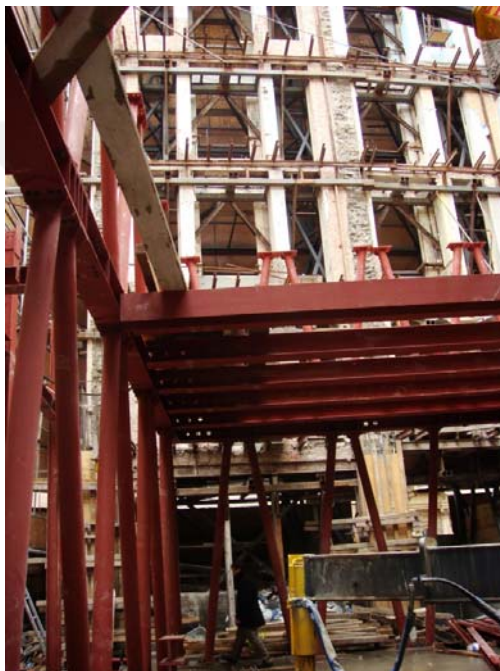
elements were completely removed, at this stage, the front facade silently awaits for construction of new load-bearing element.

**Figure 5.2** Steel supports are used to keep the frontal facade standing (GAD, February 2008)

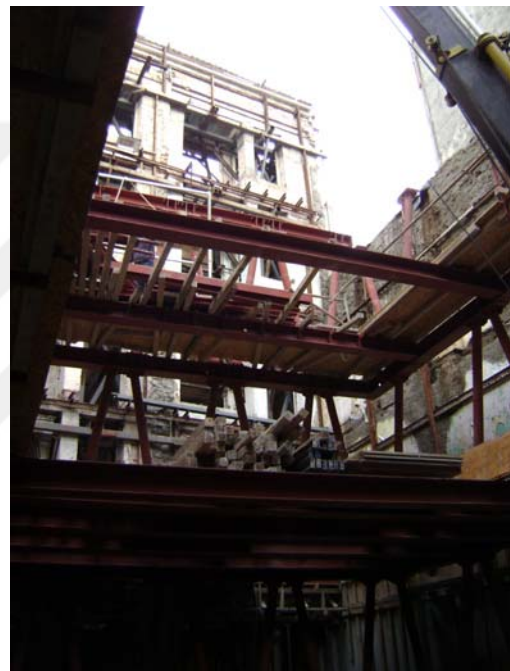
**Figure 5.3** Diagonal structure is being erected as the steel beams are placed between the layers (GAD, March 2008)

In March 2008, diagonal structure raised another level and steel beams are tied between the floors (Figure 5.3). The floor concrete was poured and the fire escape works are underway.

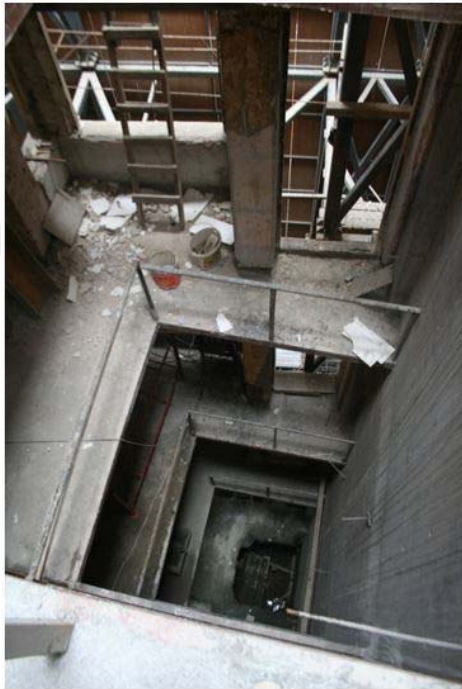
In June 2008 walls of basement, ground, first and second levels are erected. Steel sheets and concrete are laid between floors from basement until fourth level. A space was spared and encircled for security for piano elevator shaft at the ground level

**Figure 5.4** Elevator shaft  
(GAD, June 2008)

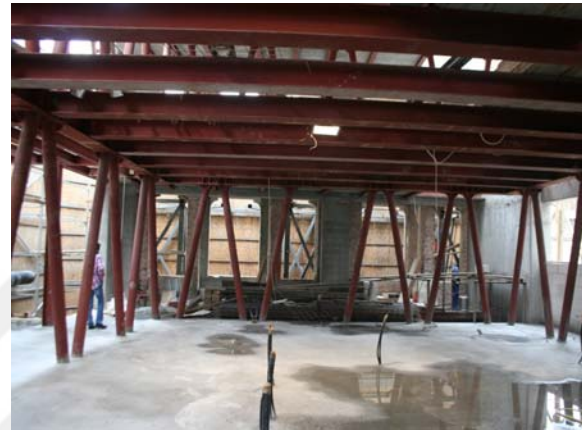
(Figure 5.4). Two steel profiles were placed to bear the stairs at the gaps of the floorings level to the stair steps. Boat outlets were placed at the determined sections of the fourth floor where offices and rehearsal rooms that specially needed electricity supply from the ground (Figure 5.5). By the end of June, the structure raised as high as the terrace level and the grounds were covered with metal sheet.

**Figure 5.5** Construction works at fourth level  
(GAD, June 2008)

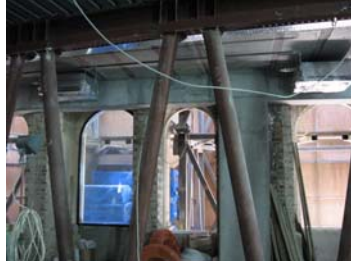
**Figure 5.7** Air conditioners were mounted on ceiling  
(GAD, August, 2008)

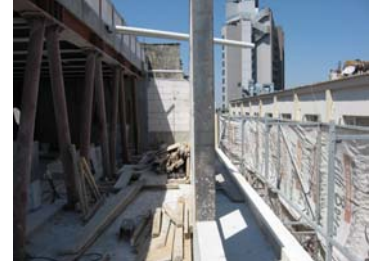
During August 2008 perforated acoustic panels were brought to the construction site. The perimeter of the washroom area was determined and the structure of drywall panels was put in place. During mounting of concrete walls gaps for such elements like fire cabinets that required niches were visible. In order to be able to execute necessary works on 3<sup>rd</sup> level ceiling, a scaffold was established in the gallery void between 2<sup>nd</sup> and 3<sup>rd</sup> levels (Figure 5.6). Side walls were made of ytong. Ventilation and air conditioning systems were installed at ceilings (Figure 5.7) and installation pipes were laid. A hole was opened at the ceiling of the fire escape stairs shaft. Construction of diagonal structure was completed up to terrace floor. The ceiling of

the terrace floor was closed while no side walls were applied (Figure 5.8). Concrete part of the parapet of the view terrace was poured.

**Figure 5.8** Construction of structure reached as high as the terrace level  
(GAD, August, 2008)

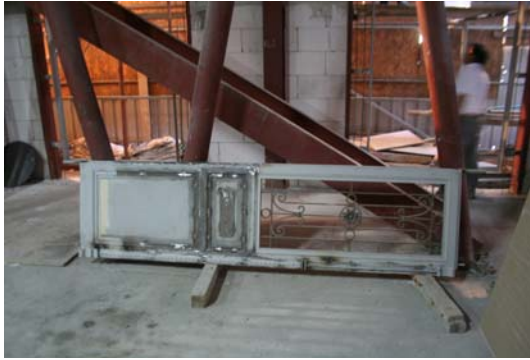
During September 2008 the original door located on side facade was renewed in construction site (Figure 5.9). Front facade fortification works and restoration were completed (Figure 5.10). Installation of windows frames started on side facades. At the side adjacent to the neighbor building was already installed with electric and water piping at the shafts that were created beforehand (Figure 5.11). Wiring and piping for smoke detector, sprinklers, lightening installations, speakers and ventilation pipes which were to be hidden above the suspended ceiling were completed. Aluminum frames of the Pop-up windows located on side walls of terrace level were installed. Also color testing on diagonal steel columns was completed. Maintenance of such parts of the building that remain inside the frontal facade was conducted and installation of ventilation pipes continued.

**Figure 5.9** Original side door was restored in situ (GAD, September 2008)

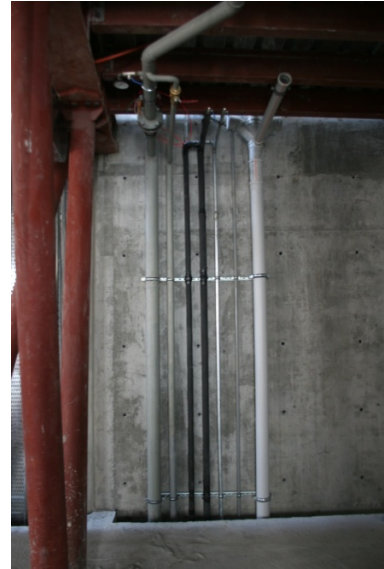
**Figure 5.11** Electricity and installation pipes were installed in the shafts (GAD, September 2008)

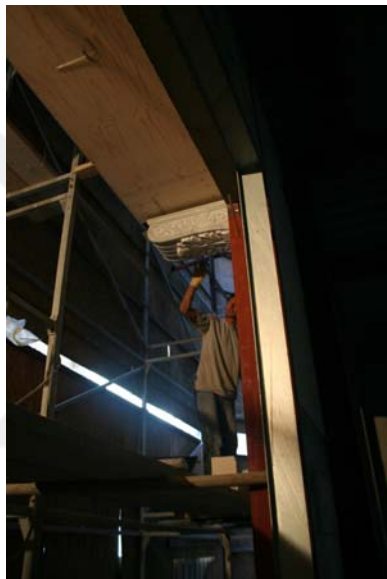
**Figure 5.10** Original front facade was restored (GAD, September 2008)

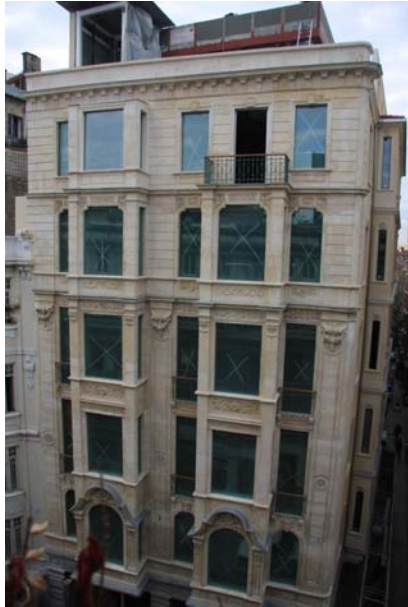
During November 2008, glass windows were installed on walls (Figure 5.12). Upon completion of works on outer shell of the building, the MDF-panel-fence was removed (except for the ground level). Frames of the side wall windows were also renewed as per the originals. The elevator structure was completed within the shaft designed for this purpose (Figure 5.13). The floor of the acoustic panel to be covered on Ytong was prepared. The windows were temporarily covered with nylon to avoid any impact of ongoing construction works. Also, the elevator shaft, which ascended up to the terrace level, was covered with a plate to prevent water from getting into.

**Figure 5.12** Outer windows of the building were installed (GAD, November 2008)

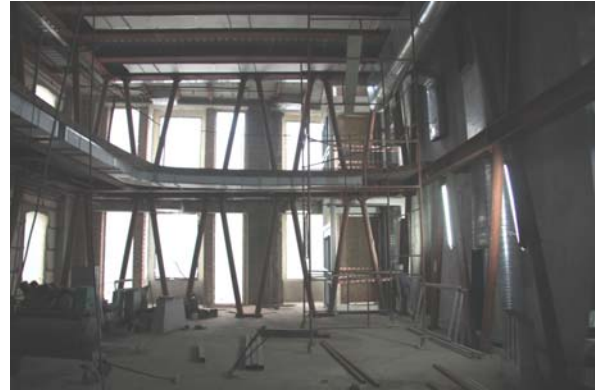
**Figure 5.13** Elevator structure was installed while construction of 2<sup>nd</sup> and 3<sup>rd</sup> floor gallery void was still ongoing (GAD, November 2008)

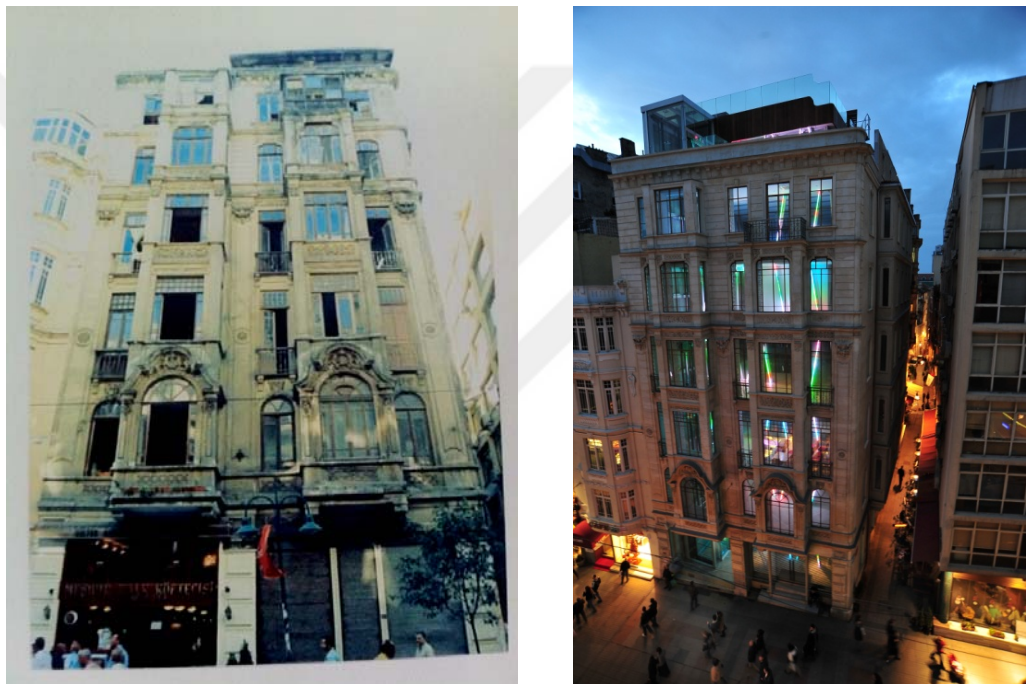
**Figure 5.14** Form function comparison between old front facade and new front facade

Indeed, it is a completely different structure as result of the renovations made with loyalty to the former structure, when looked from outside. One faces the technology and thought structure of the 21<sup>st</sup> century although the number of windows and entrances we see are the same on the facade (Figure 5.14). The people, who used to be anxious while passing by the structure which was about to collapse, are now admirers of the structure.
