**RENOVATION AND RECLAMATION OF OLD BUILDINGS IN  
İSTANBUL: THE CASE OF BORUSAN MUSIC HOUSE IN BEYOĞLU**

**A THESIS SUBMITTED TO  
THE GRADUATE SCHOOL OF NATURAL AND APPLIED  
SCIENCES OF  
ÇANKAYA UNIVERSITY**

**IN PARTIAL FULFILLMENT OF THE REQUIREMENTS FOR THE  
DEGREE OF  
MASTER OF SCIENCE  
IN  
THE DEPARTMENT OF  
INTERIOR ARCHITECTURE**

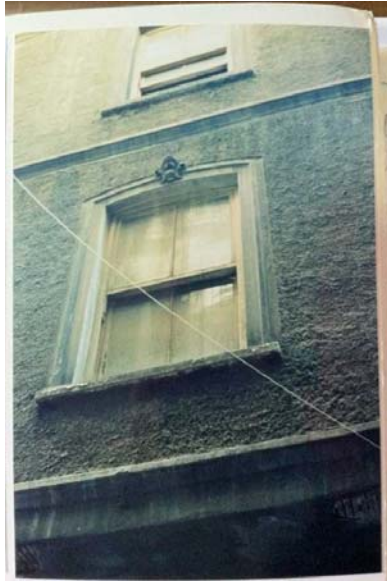
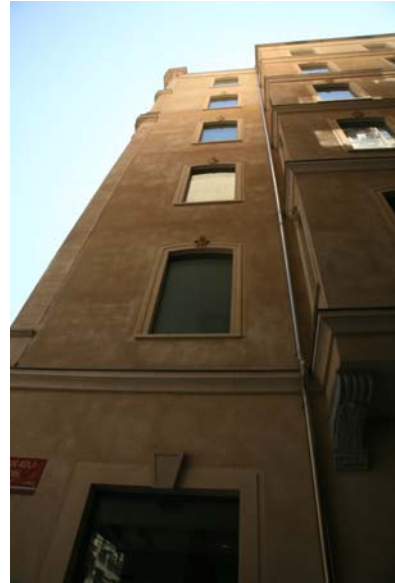
**Figure 5.15** Form function comparison between old side facade and new side facade

Although the structure which used to have opening windows does not have opening windows now, it is possible to have fresher air in the structure now. Form of the structure was not changed; however, it is now in a soul keeping pace with the street's modern form. Although we can feel porous surface of the side facade only on the photographs, it must not be forgotten that the renewed facade insulated the temperature inside it for the future of world (Figure 5.15).

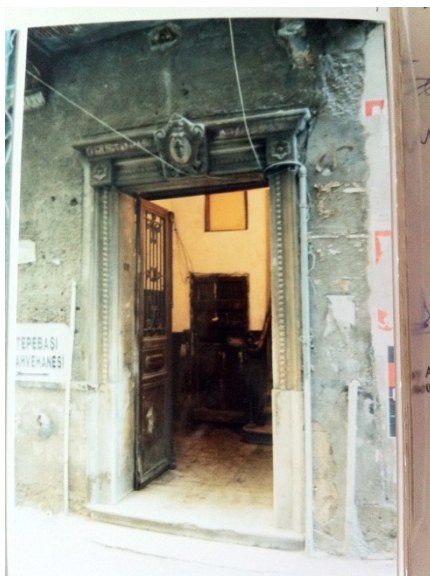
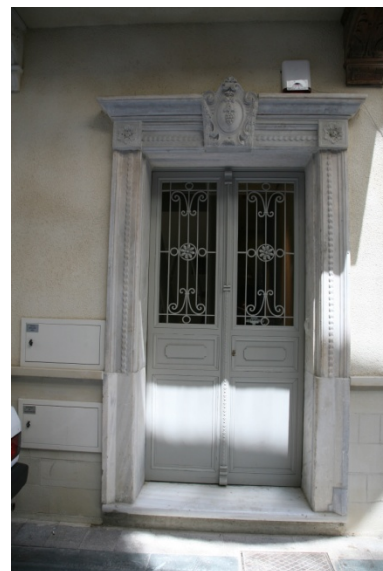
**Figure 5.16** Form function comparison between old side entrance gate new side exit door function comparisons

The place of restaurant, which was faced when entered from the main door in the 19<sup>th</sup> century, was taken by the art works in the 21<sup>st</sup> century. The stairs which used to appear when entered from the side door to the structure in the 19<sup>th</sup> century left their place to the exit area equipped with the latest technology which can be trusted in emergencies (Figure 5.16).

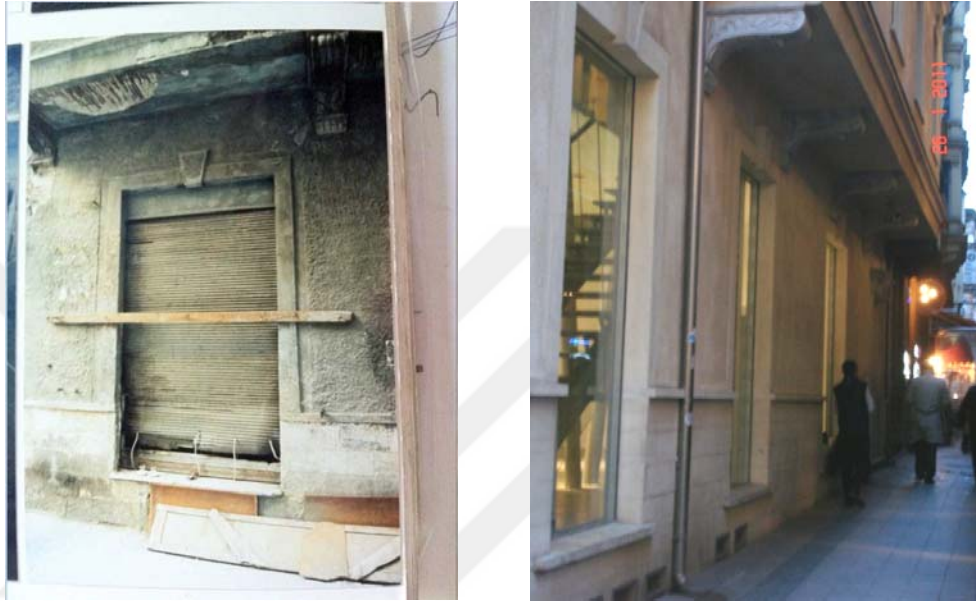
**Figure 5.17** Form function comparison of old ground floor's side facade and new ground floor's side facade

The fact that the windows of side facade which is as valuable as if it has a view of Bosphorus gives us the idea that this area was used as warehouse in the past. Now, this valuable facade must be protected with the same form. It is targeted to meet public and art by removing the walls in İstiklal Avenue, most of which are used as culture center and art house (Figure 5.17).

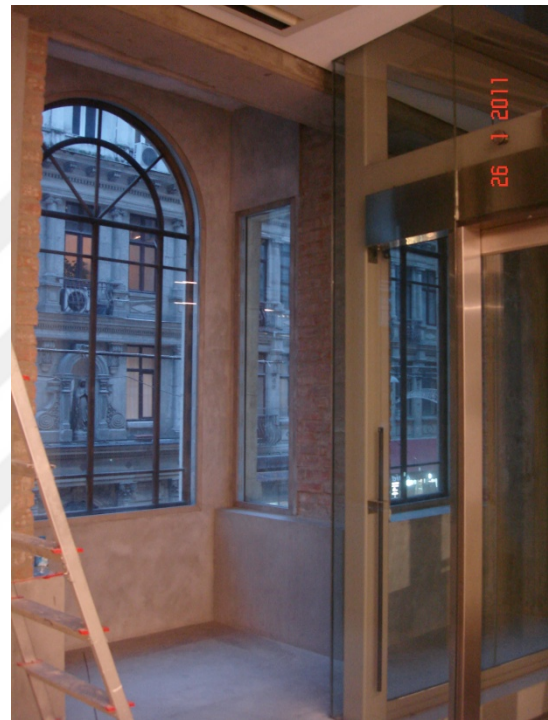
**Figure 5.19** The first floor front facade elevator relation

place. Synchronization of the elevator made of glass and steel with the old facade is the most significant frame of change (see Figure 5.19).

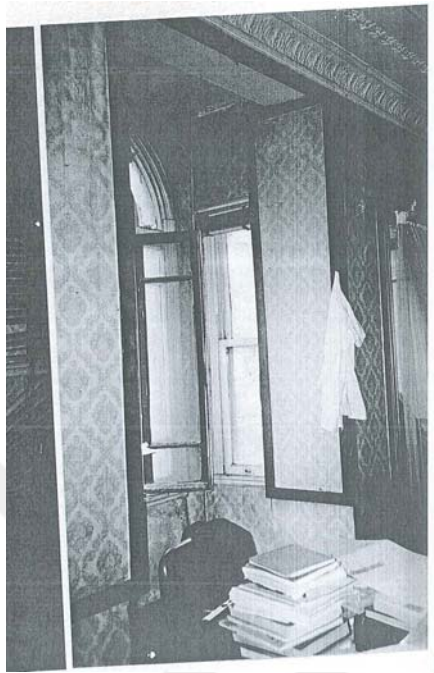
**Figure 5.20** The first floor old ceiling decoration

The ceiling detail seen on the photograph taken from the first floor before restoration is thought to be a detail worth for protection if it didn't lose its structure. The books stacked on the table on the photograph shows us the life experience of old state of the structure. Today, in the same place, changing exhibitions are established. It is seen that there is nothing left from the past in ceiling materials. By contrast, it is known that the air-conditioner system embedded in ceiling has taken the place of non-opening windows in the place (Figure 5.21).

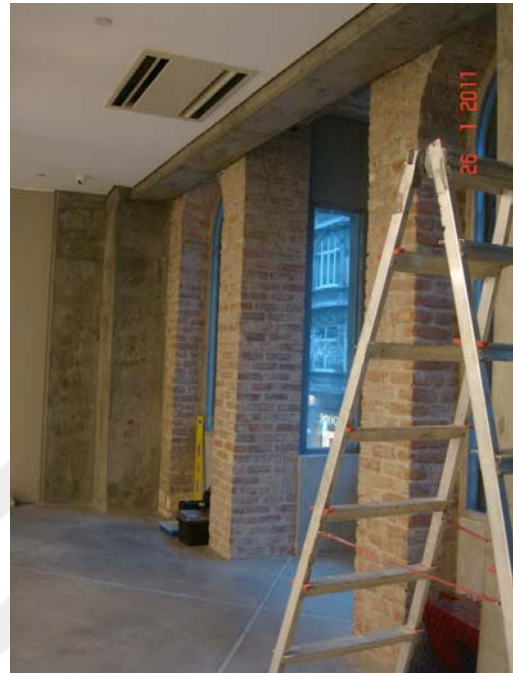
**Figure 5.21.** Current state of the photograph in Figure 5.20

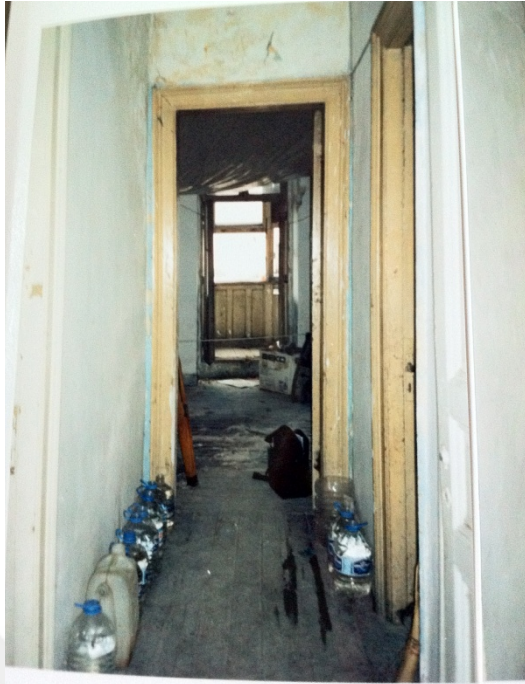
**Figure 5.24** Old fifth floor corridor and balcony

According to the information obtained from fifth floor photographs before restoration: The balcony door on the front facade is double-winged woodwork (Figure 5.24). Balcony part is accessed with one step. The sides of balcony were painted to cream color and the balcony was closed with glass work with wooden frame. The corridor in same axis with this balcony is opened to the rooms from right, left and main place. There is one more photograph taken before restoration from the room with balcony. In this figure, it is seen that the walls are painted to white, frames

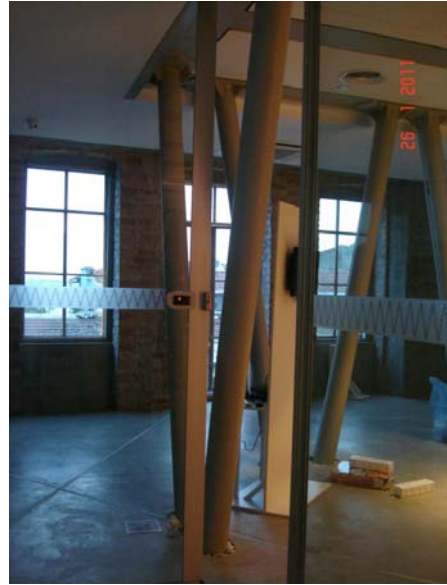
**Figure 5.26** The fifth floor and balcony door

Old form of the fifth floor used as living area has turned into one of exhibition floors of BMH today. As result of this change, everything but balconies and windows on the front side were changed (Figure 5.26). New balcony door and windows were made on the same line with old wooded frames, but they are in different colors. Balcony door is double winged again. But the balcony is not closed anymore. The floor with many separator walls and doors has left its place to a single area.

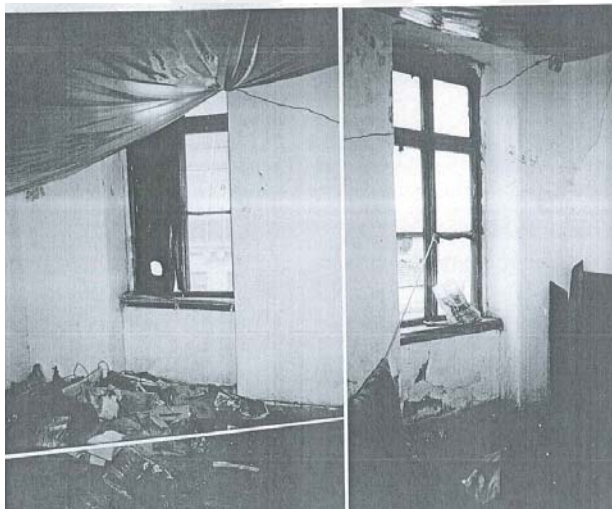
**Figure 5.25** Old fifth floor

are wooden and there are wooden ledges on the front side of them (Figure 5.25). The ceiling material is not seen because of the tarp coated by the users. The possible reason of need of tarp is thought to be the water leakage from the ceiling. Indeed, it is seen that tarp was used instead of the broken glass (Figure 5.25).

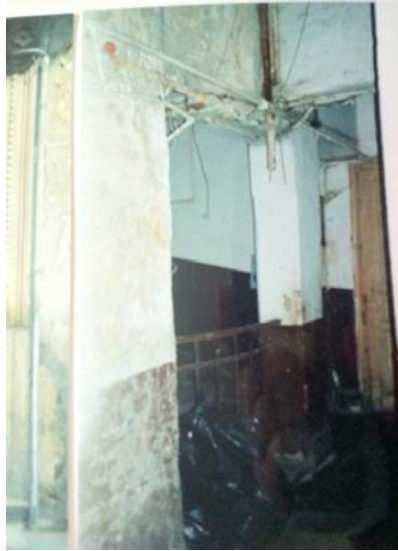
**Figure 5.27** Old structural system,  
concrete column

Old masonry retrofit structural system needed to be completely demolished as is such old that it could not be strengthened (Figure 5.27). Structure has been demolished but floor heights and facade borders have continued to be protected. The diagonal steel structure which is the new structural system allows creating large openings. In this way, openings needed for new functions are obtained and the structure is strengthened. Strengthening of the structure is very important for protecting the structure from earthquake. Second benefit of renewal of the structure is in terms of aesthetics. Lightings attached to the structure with electrical outlets made on the bottom of each column are in compliance with the structure's dynamics. The new structure feels the fiction of place in place, rather than separating the place into parts. Steel structure is not an object blocking passage or an object in need of protection. The new structure can be named as a separator panel with passage (Figure 5.28).

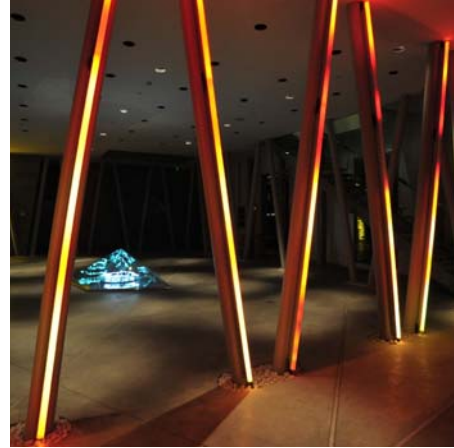
**Figure 5.28** New structural system,  
diagonal steel columns

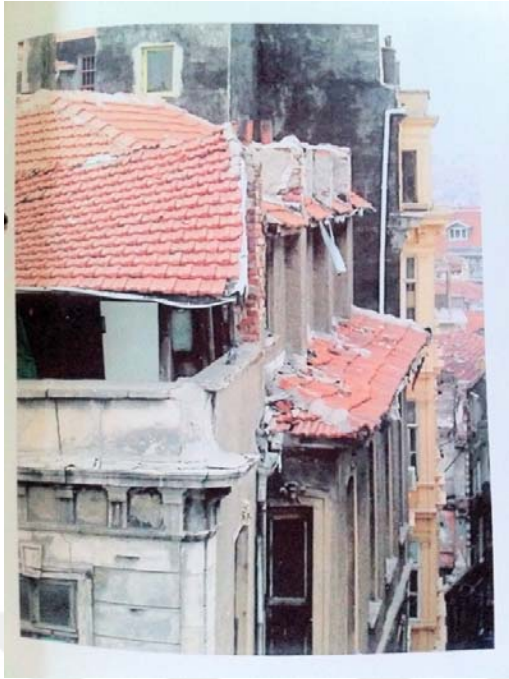
**Figure 5.29** Roof floor old structural system, tile roof

One of the biggest changes has been the renovation of terrace floor. As result of release of load made on the structure by old roof, BMH had a design with view terrace. On the photograph taken before restoration, it is seen that the old stacked structure is dangerous (Figure 5.29). As result of the fact that floor height of the old structure was not changed, the terrace floor starts at the line where the older front facade ends. Diagonal steel structure is seen in this floor too. With help of the water proof materials used instead of roof in BMH, schematic and publicly available view terrace was obtained (Figure 3.30).

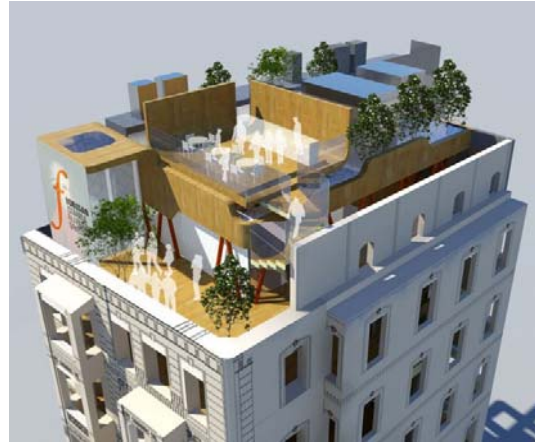
**Figure 5.30** Roof floor new structural system

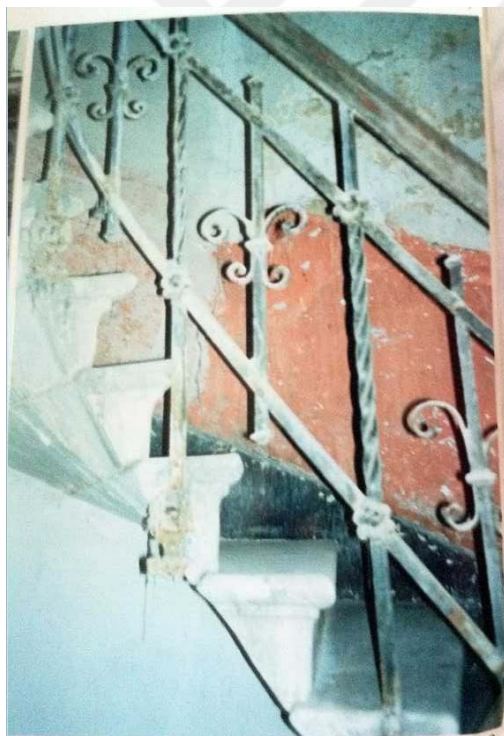
**Figure 5.31** Old concrete stairs

Materials, as well as the places, of structure's stairs were changed and adopted to today. Steel carrier stairs have taken the place of old concrete stairs. Straight glass has taken the place of old wrought iron wooden handle parapet. Walls of stairs and plasters are painted (Figure 5.31). In the new application, walls next to stairs are coated with perforated acoustic panels. Old stairs have created a place within themselves. New stairs have joined the place as design objects (Figure 5.32).

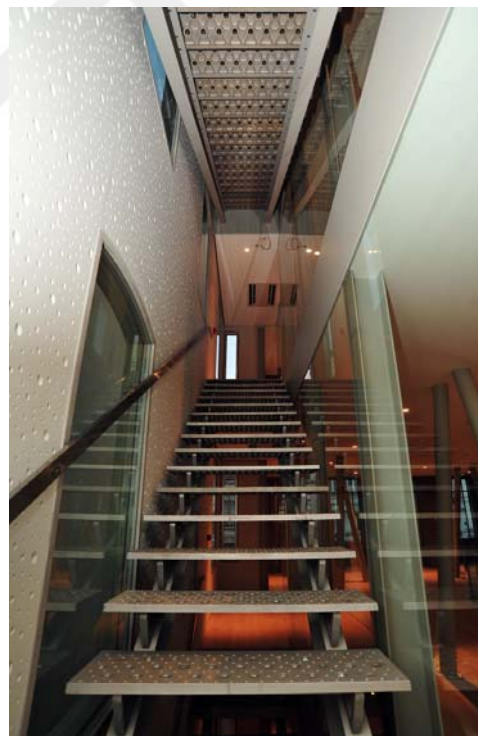
**Figure 5.32** New steel stairs

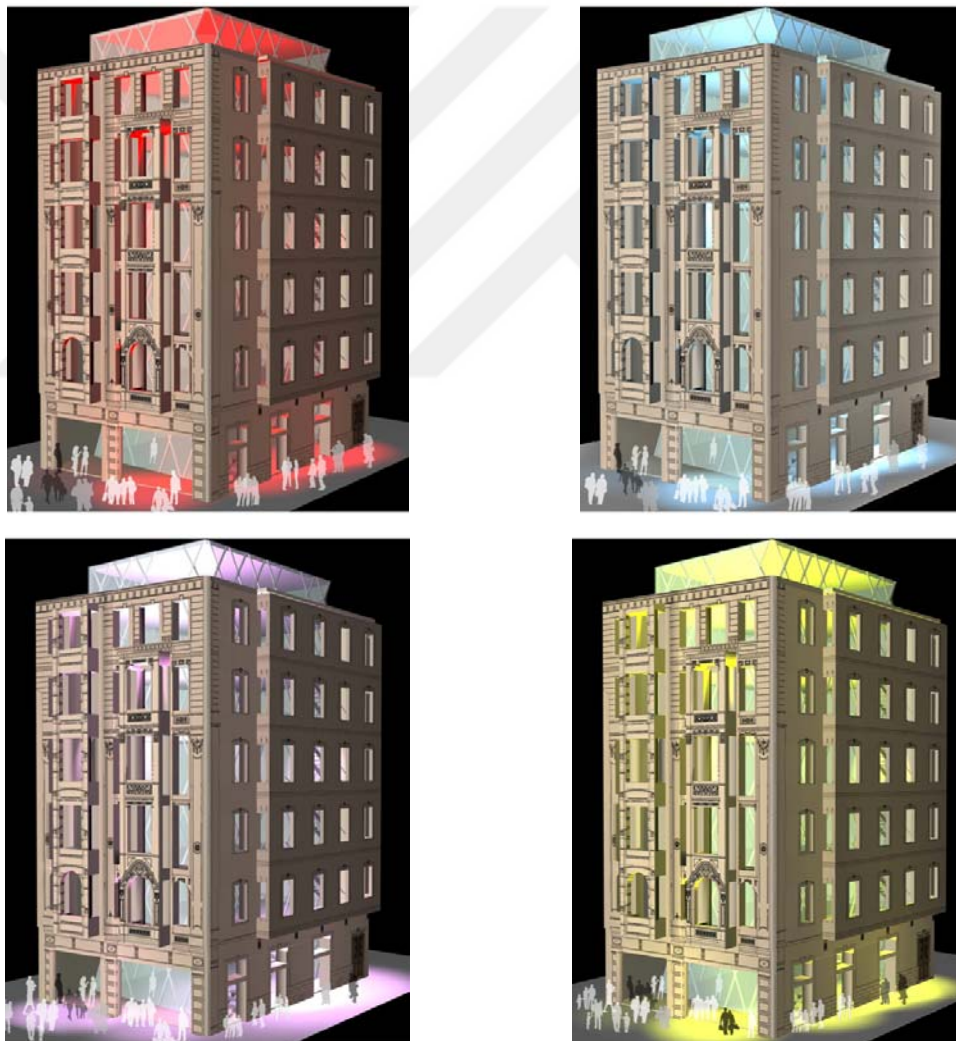
**Figure 5.33** The new lighting system which is located from inside to the outer facade and which has red, blue, purple and yellow colors lighting respectively

are used separately or mobile by winging on request (see Figure 5.33). Although it is an art work, it was adopted to the building. So, the artist has contributed to the structure with adjustments during and after assembly (see Figure 5.34).

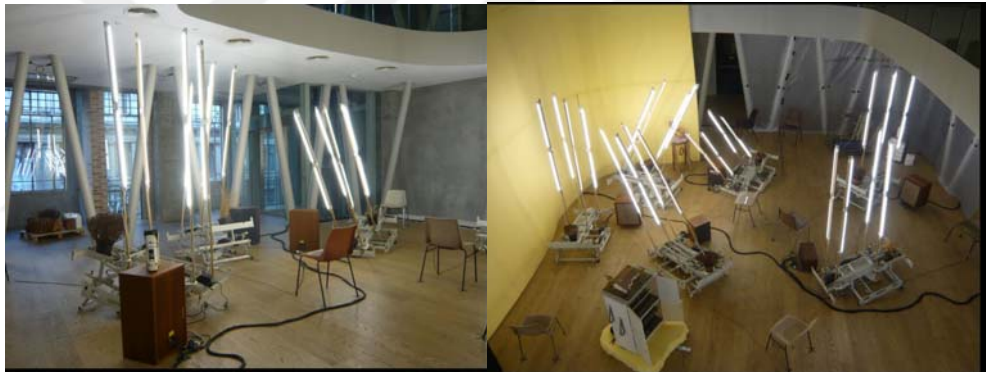
**Figure 5.34** Figure assembly works of the art works on diagonal structure
